# Coastal Erosion Processes and Mitigation Measures

**San Francisco Littoral Cell, Pacifica Sub Cell**

**Bob Battalio, PE  
Principal Engineer, ESA PWA**

**November 14, 2012  
City of Pacifica**

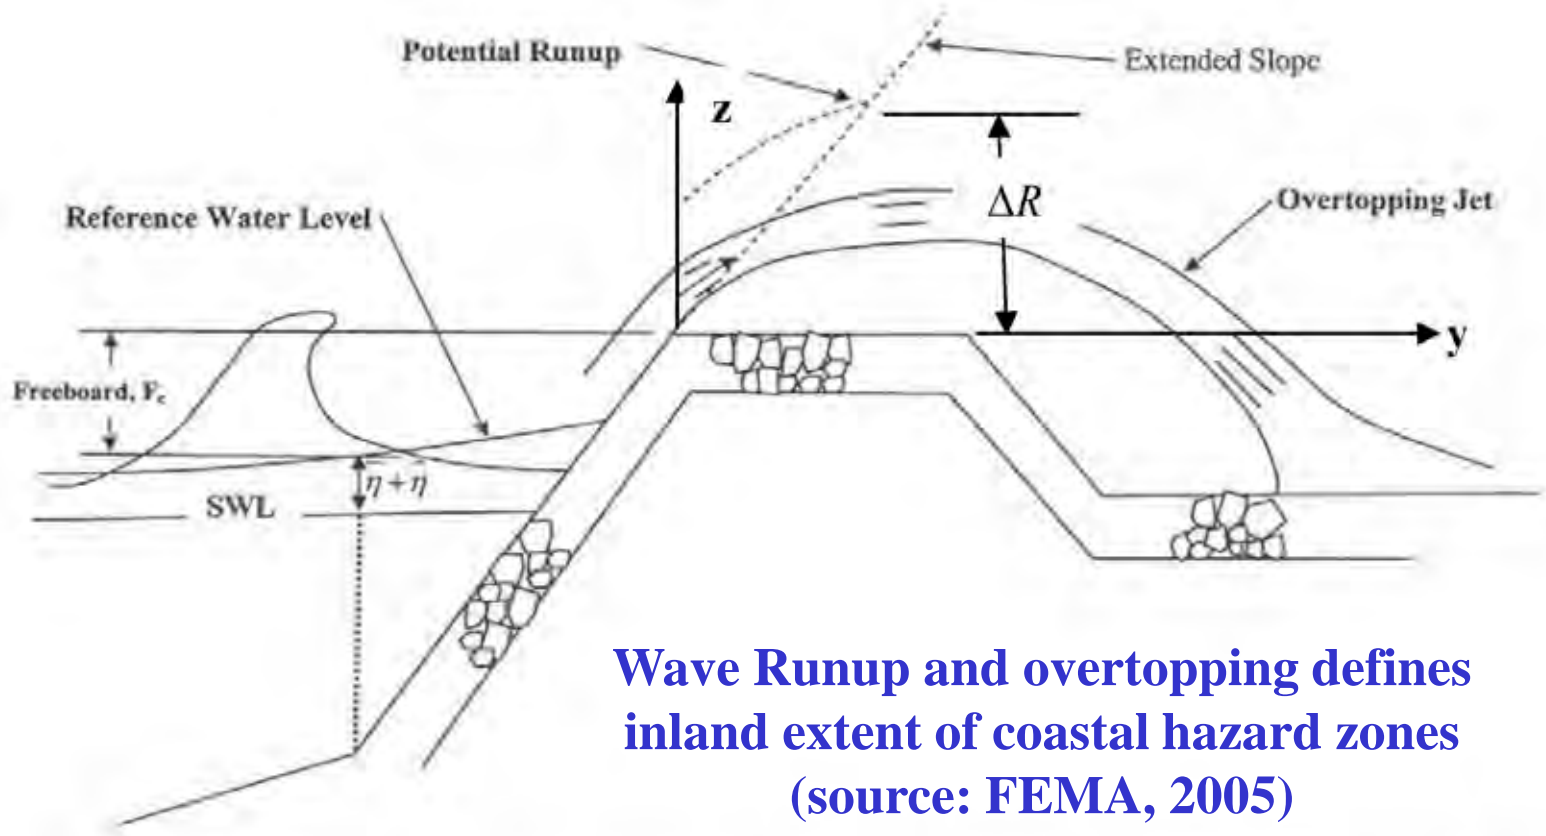
**Figure D.4.5-13. Parameters Available for Mapping BFEs and Flood Hazard Zones**

**Table D.4.5-6. Overtopping Parameters Used in Hazard Zone Mapping**

Parameter	Variable	Units
Total potential runup elevation	$R$	ft
Mean overtopping rate	$q$	cfs/ft
Landward extent of green water and splash overtopping	$y_{G,Outer}$	ft
Depth of overtopping water at a distance $y$ landward of crest	$h(y)$	ft

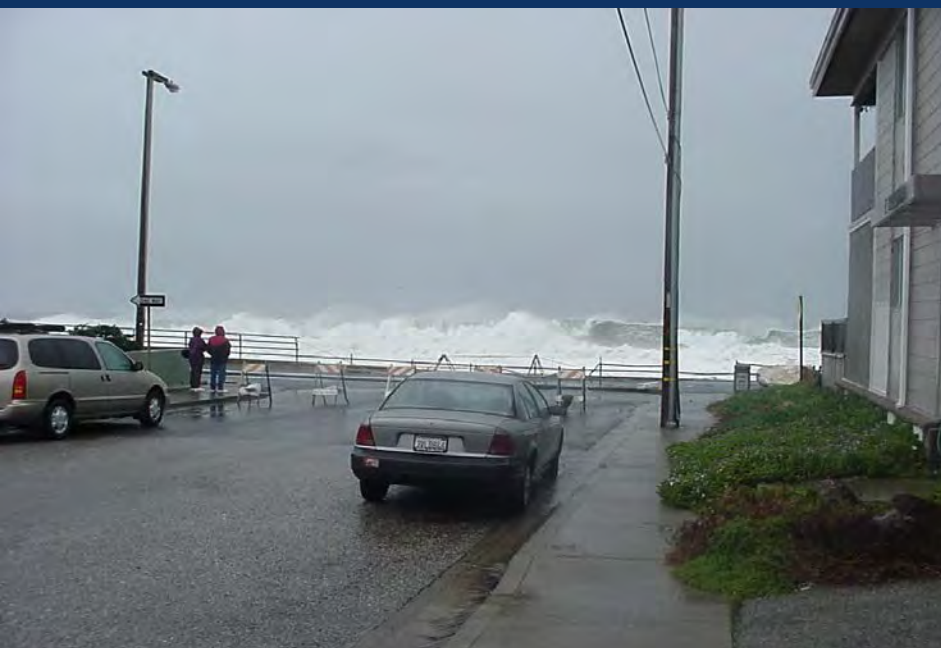
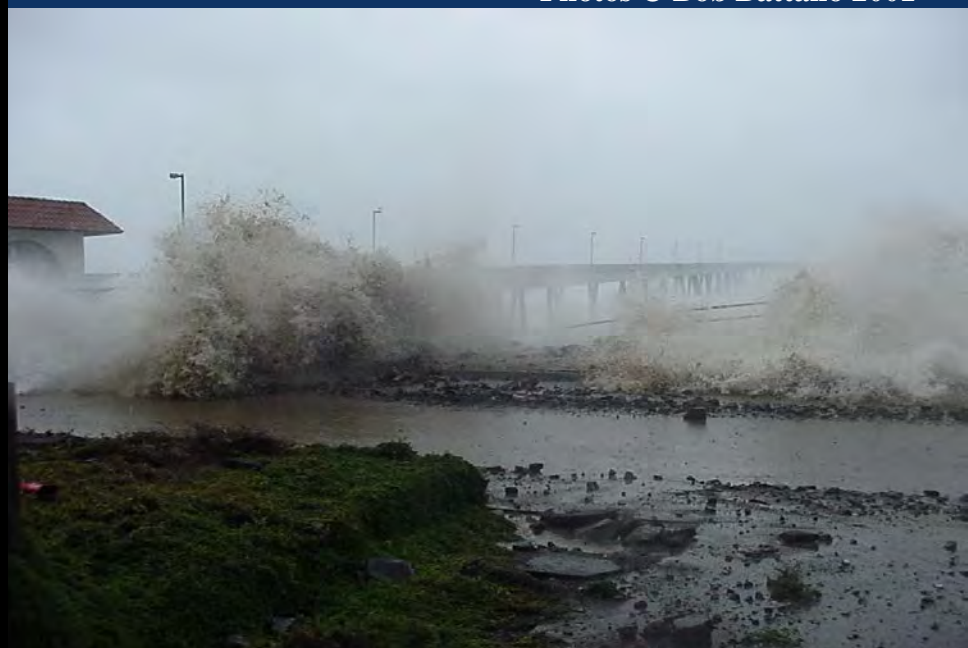
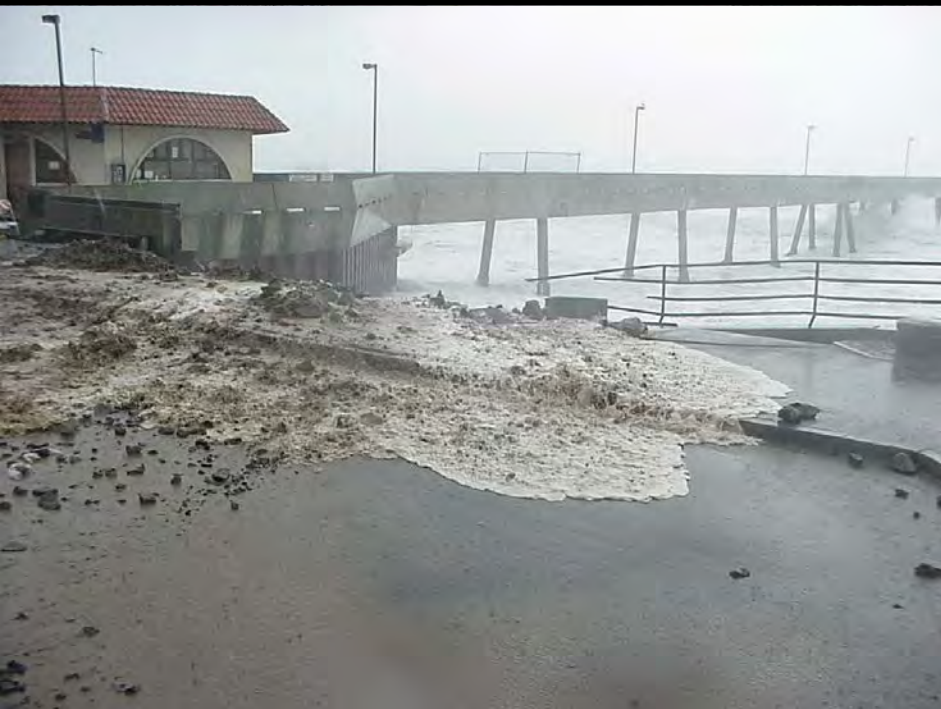
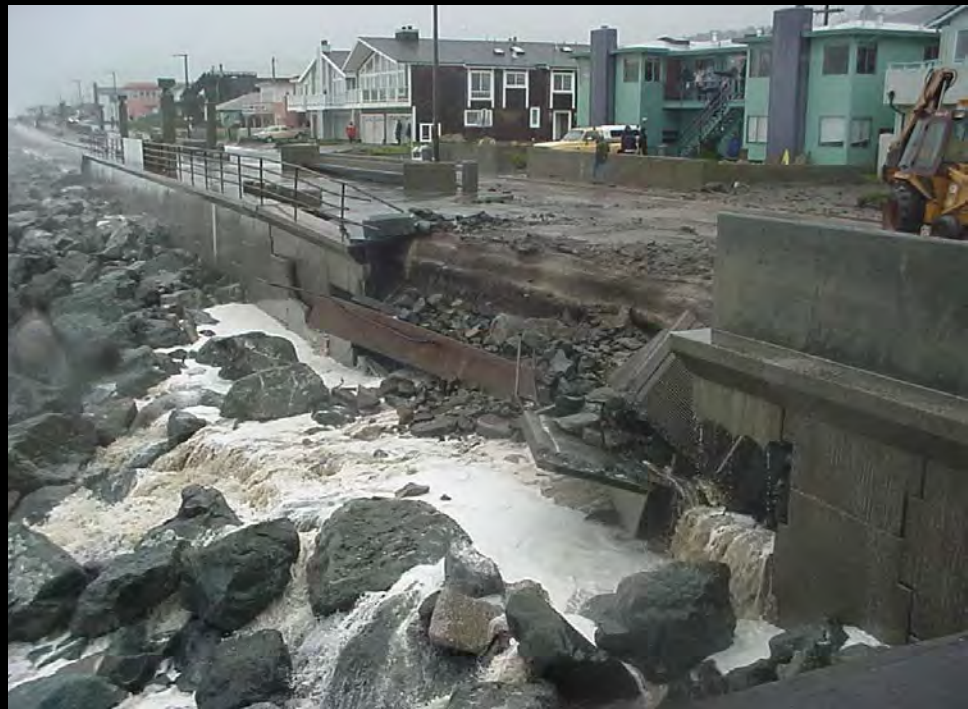
Sharp Park Seawall, Pacifica, CA – Jan 11, 2001

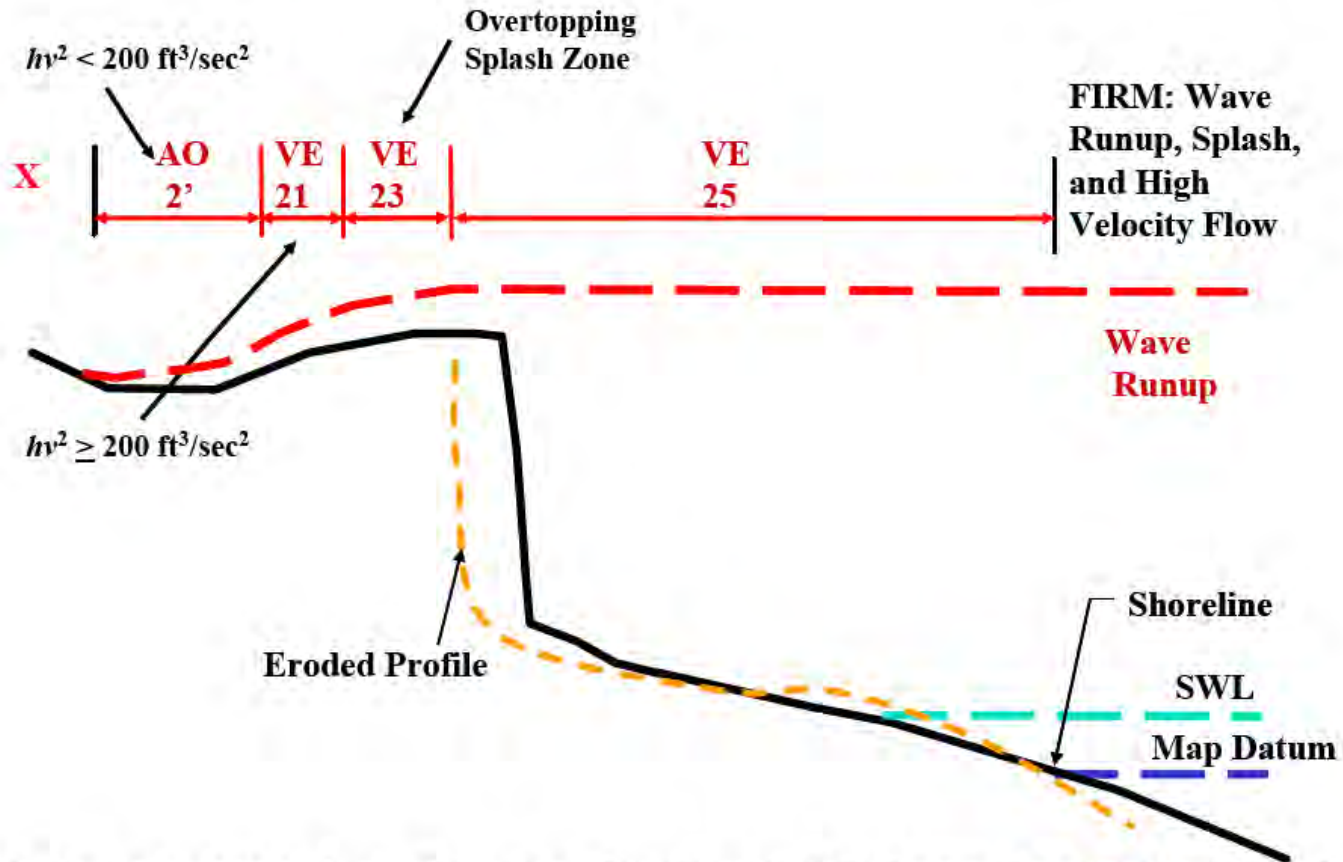
Figure D.4.9-5a. Erodible Low Coastal Bluff with VE Zone Controlled by Wave Runup, Overtopping Splash, and High-velocity Flow

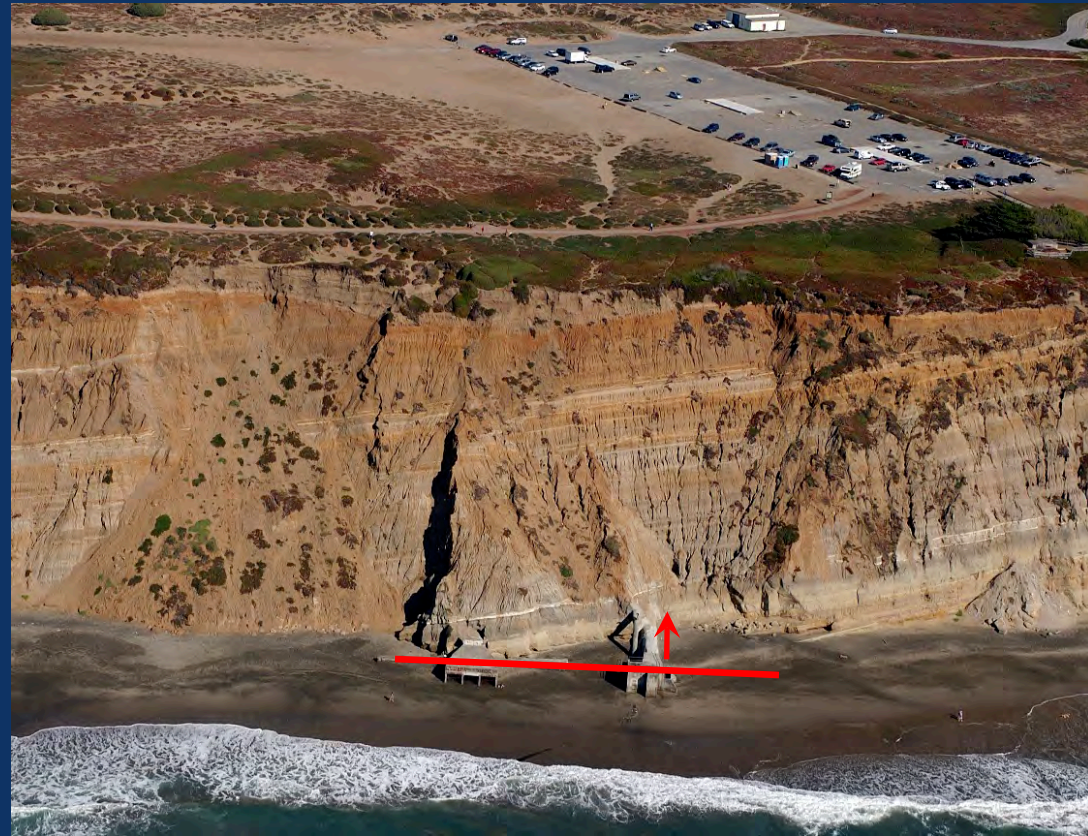
## Example – Daly City, CA

- Narrow beach backed by ~150 ft bluffs
- Merced Formation (fine to medium grained sand, weakly consolidated)
- Prone to large slumps and landslides
- Long-term erosion rate of 1.3-1.6 ft/yr
- Future erosion predicted to be 1.8-4.5 ft/yr, 3 ft/yr recommended for infrastructure setback

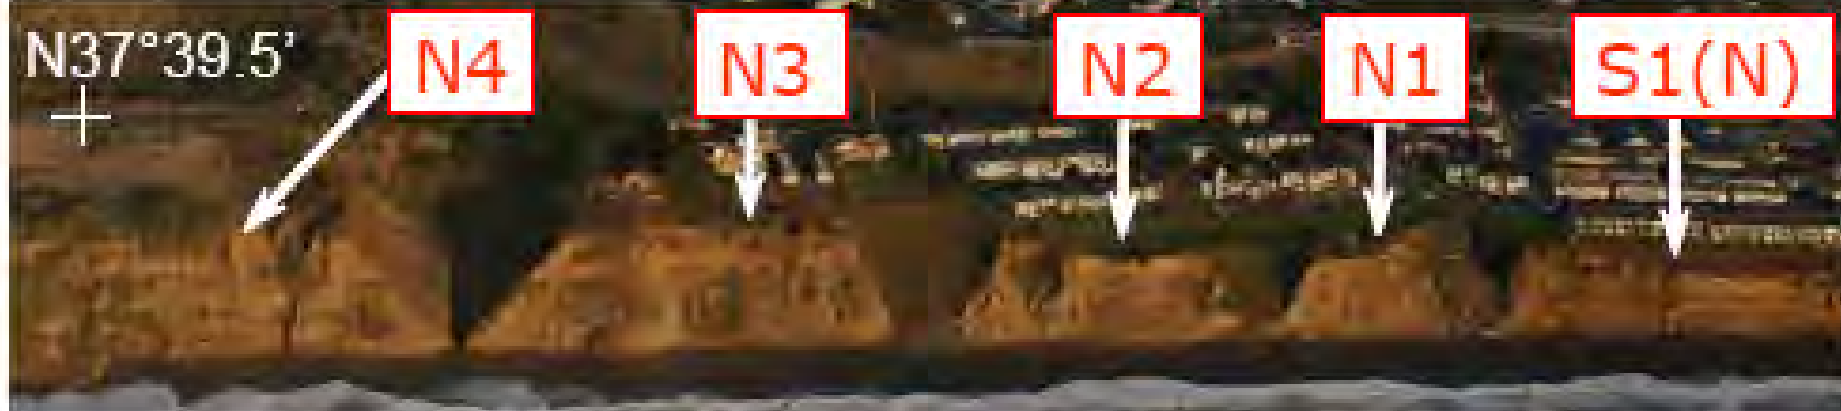
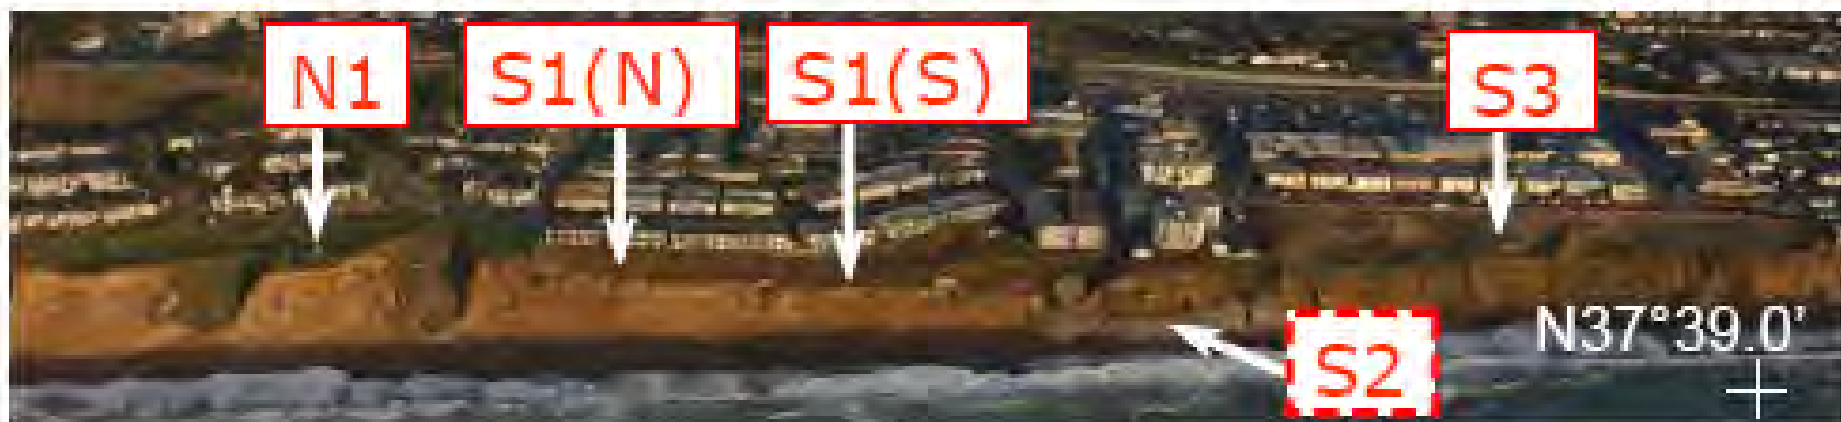
Figure 3. Oblique view of the Pacifica study area showing locations of observed cliffs. Cliff S2 was not observed for failures. Photo courtesy of the California Coastal Records Project.

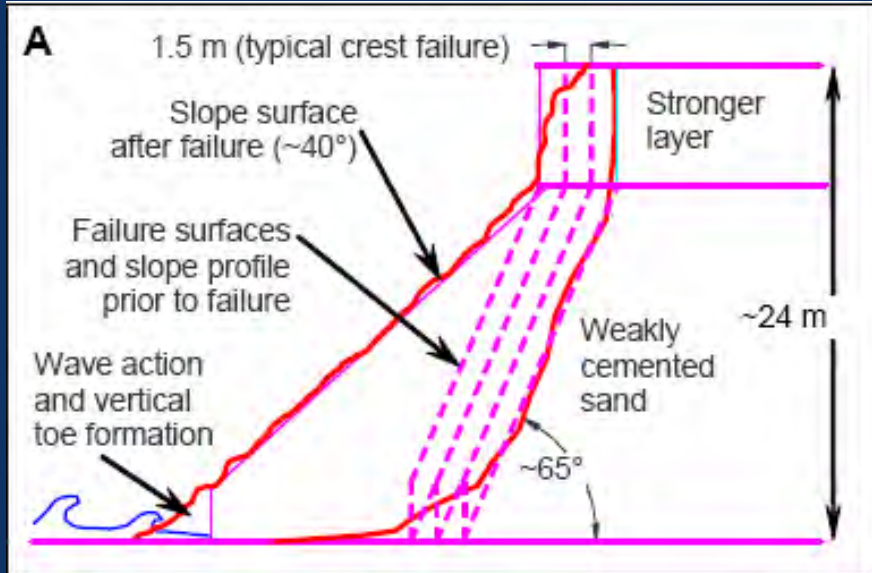
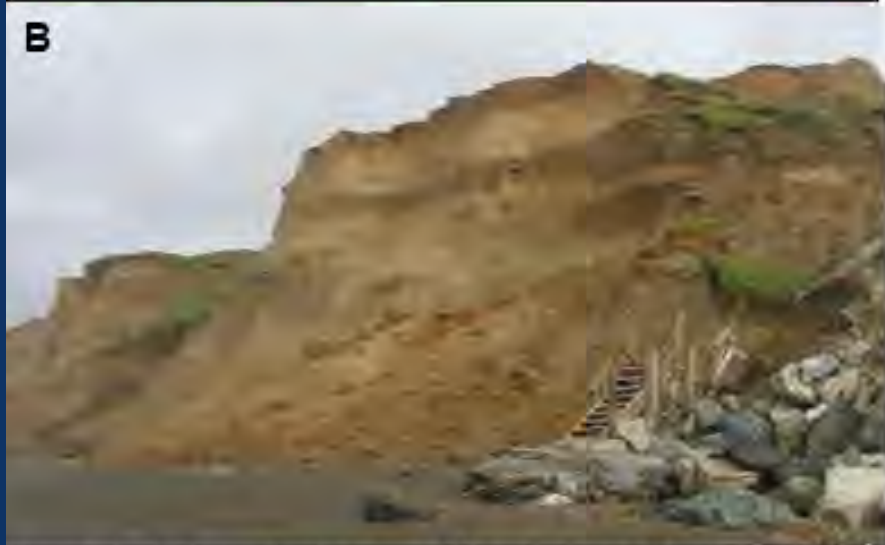
Figure 4. Schematic diagram (A) and photo (B) of weakly cemented coastal cliff failure mode. The failure surface is typically inclined at  $65^\circ$  to the horizontal.

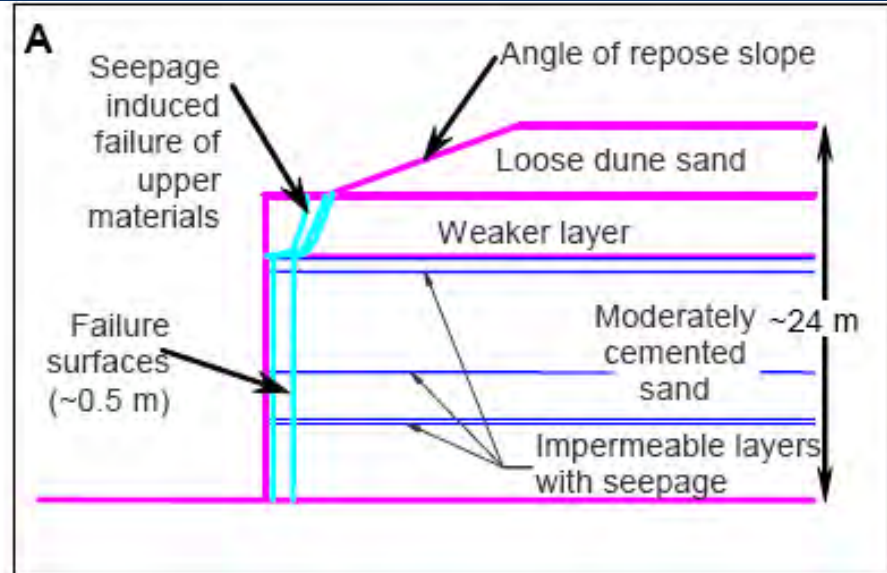
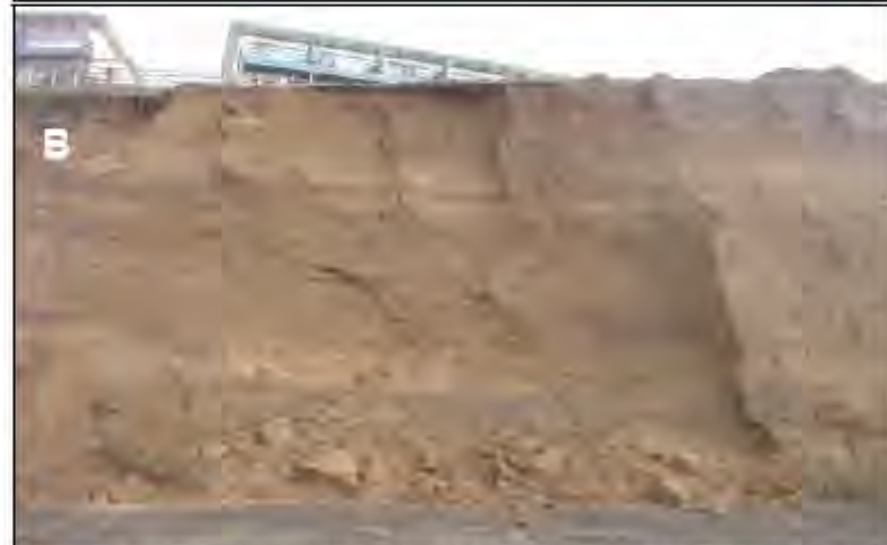
Figure 5. Schematic diagram (A) and photo (B) of moderately cemented coastal cliff failure mode. The failure surface is typically near-vertical.

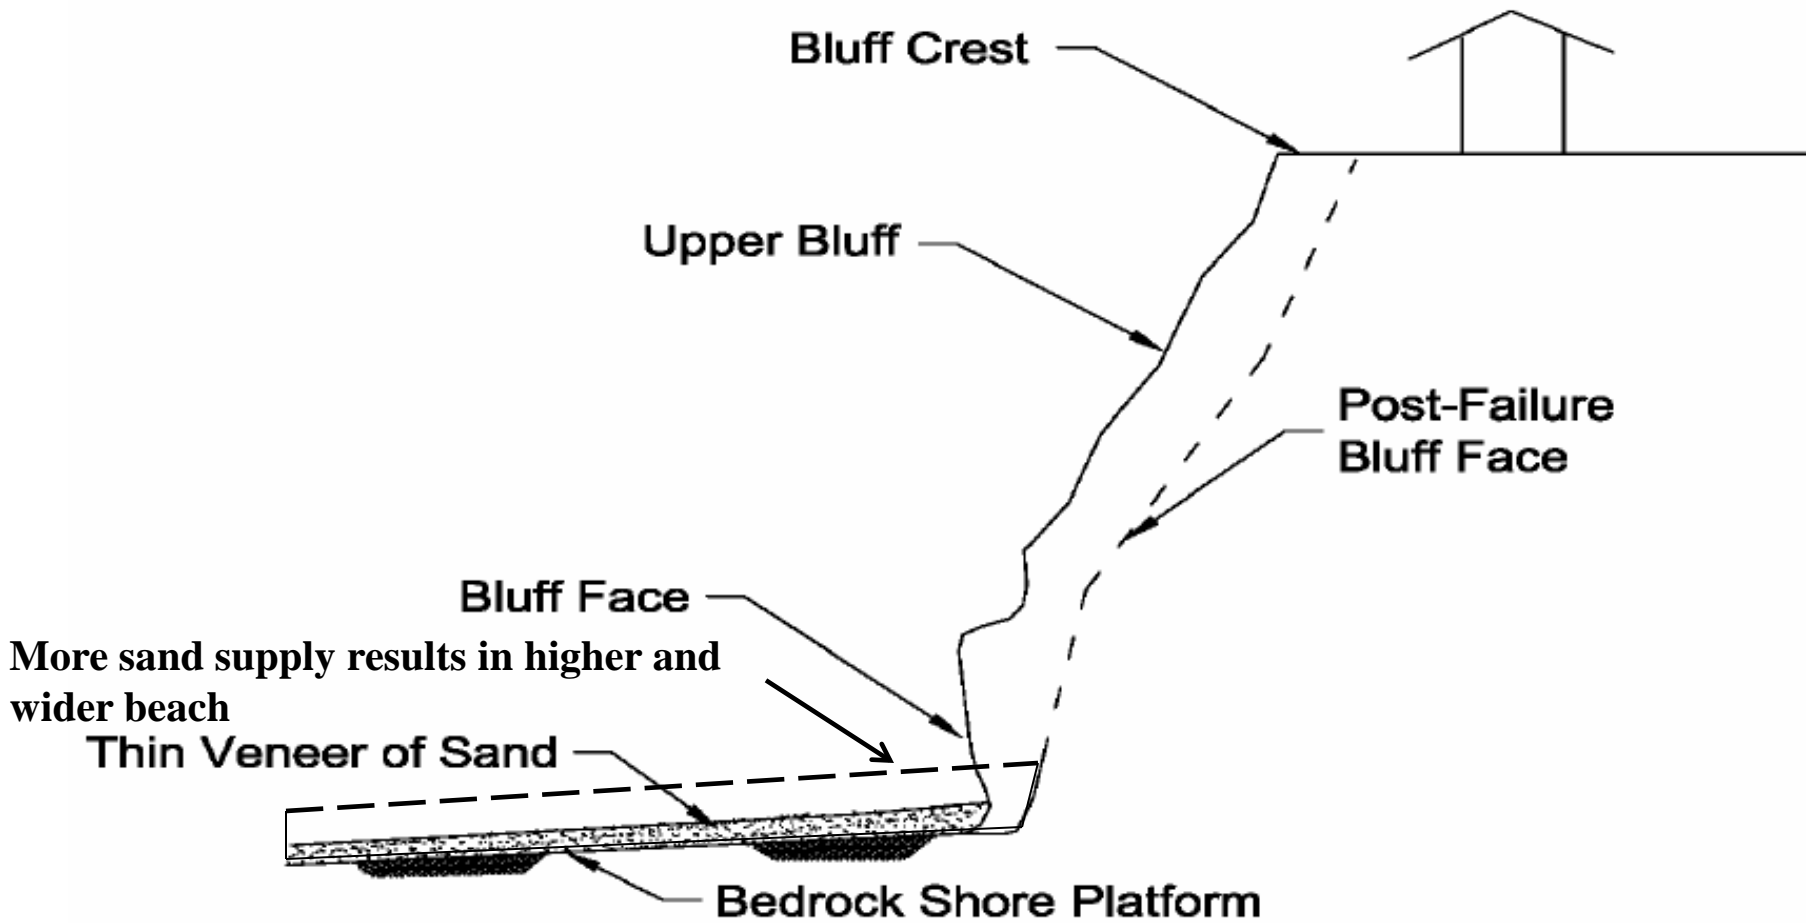
**Figure D.4.6-31. Typical Erodible Bluff Profile Fronted by Narrow Sand-capped Beach**

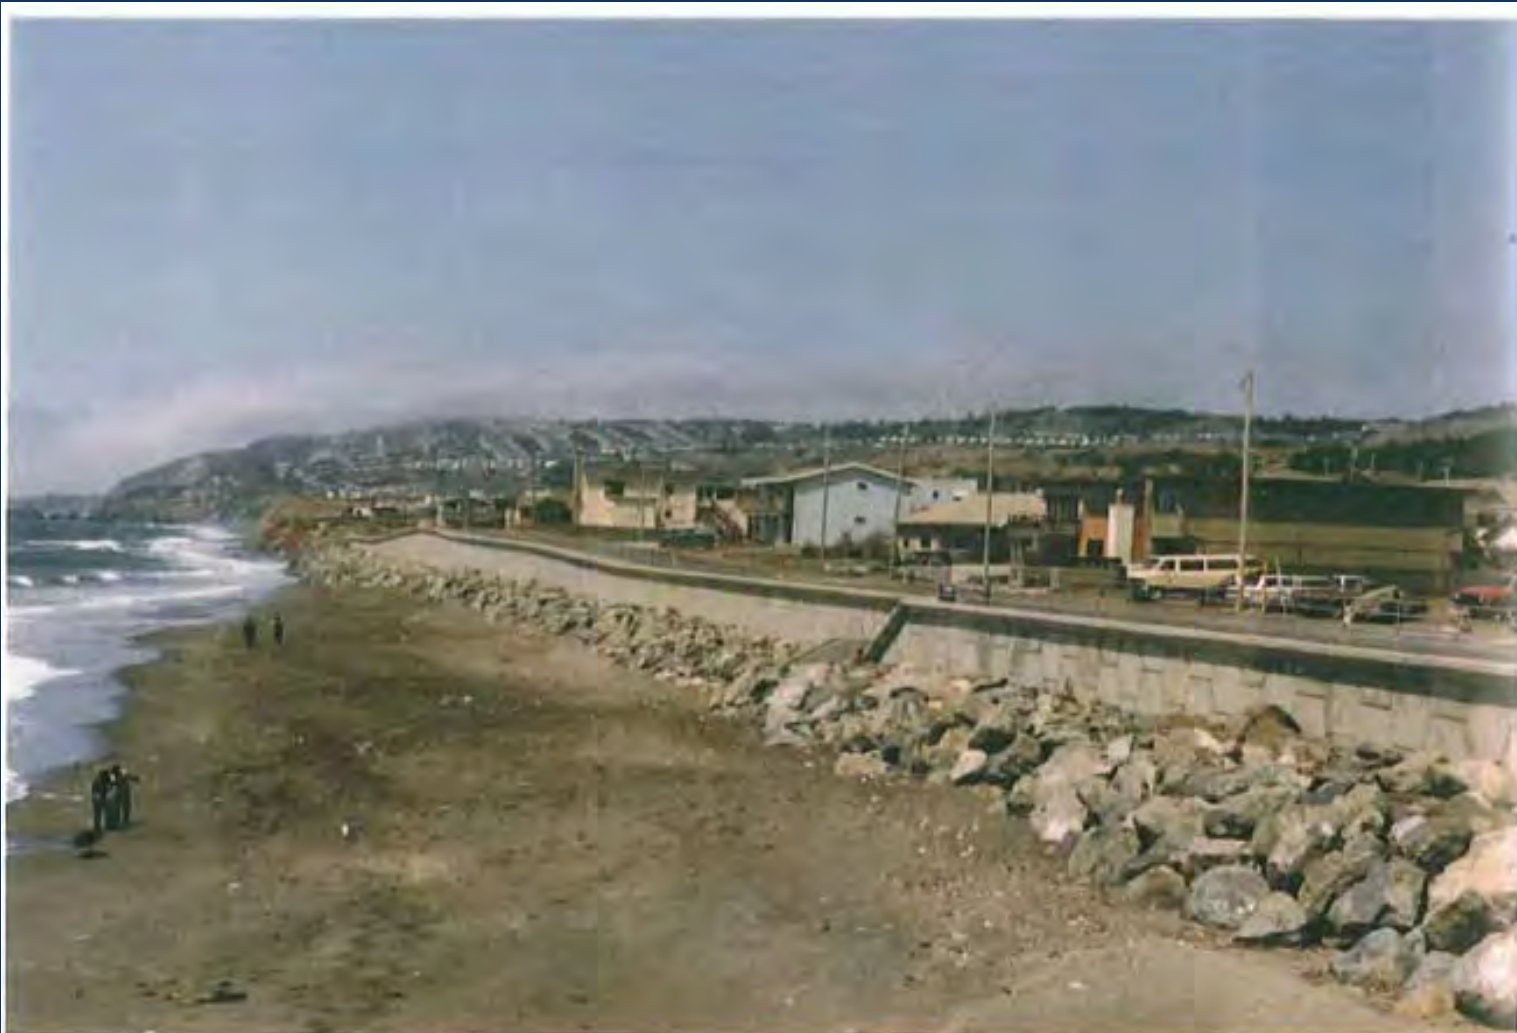
Photograph 6. Recently constructed reinforced earth seawall with armor stone toe protection. This wall extends along Beach Boulevard north of the Fishing Pier in Pacifica (August 1985).

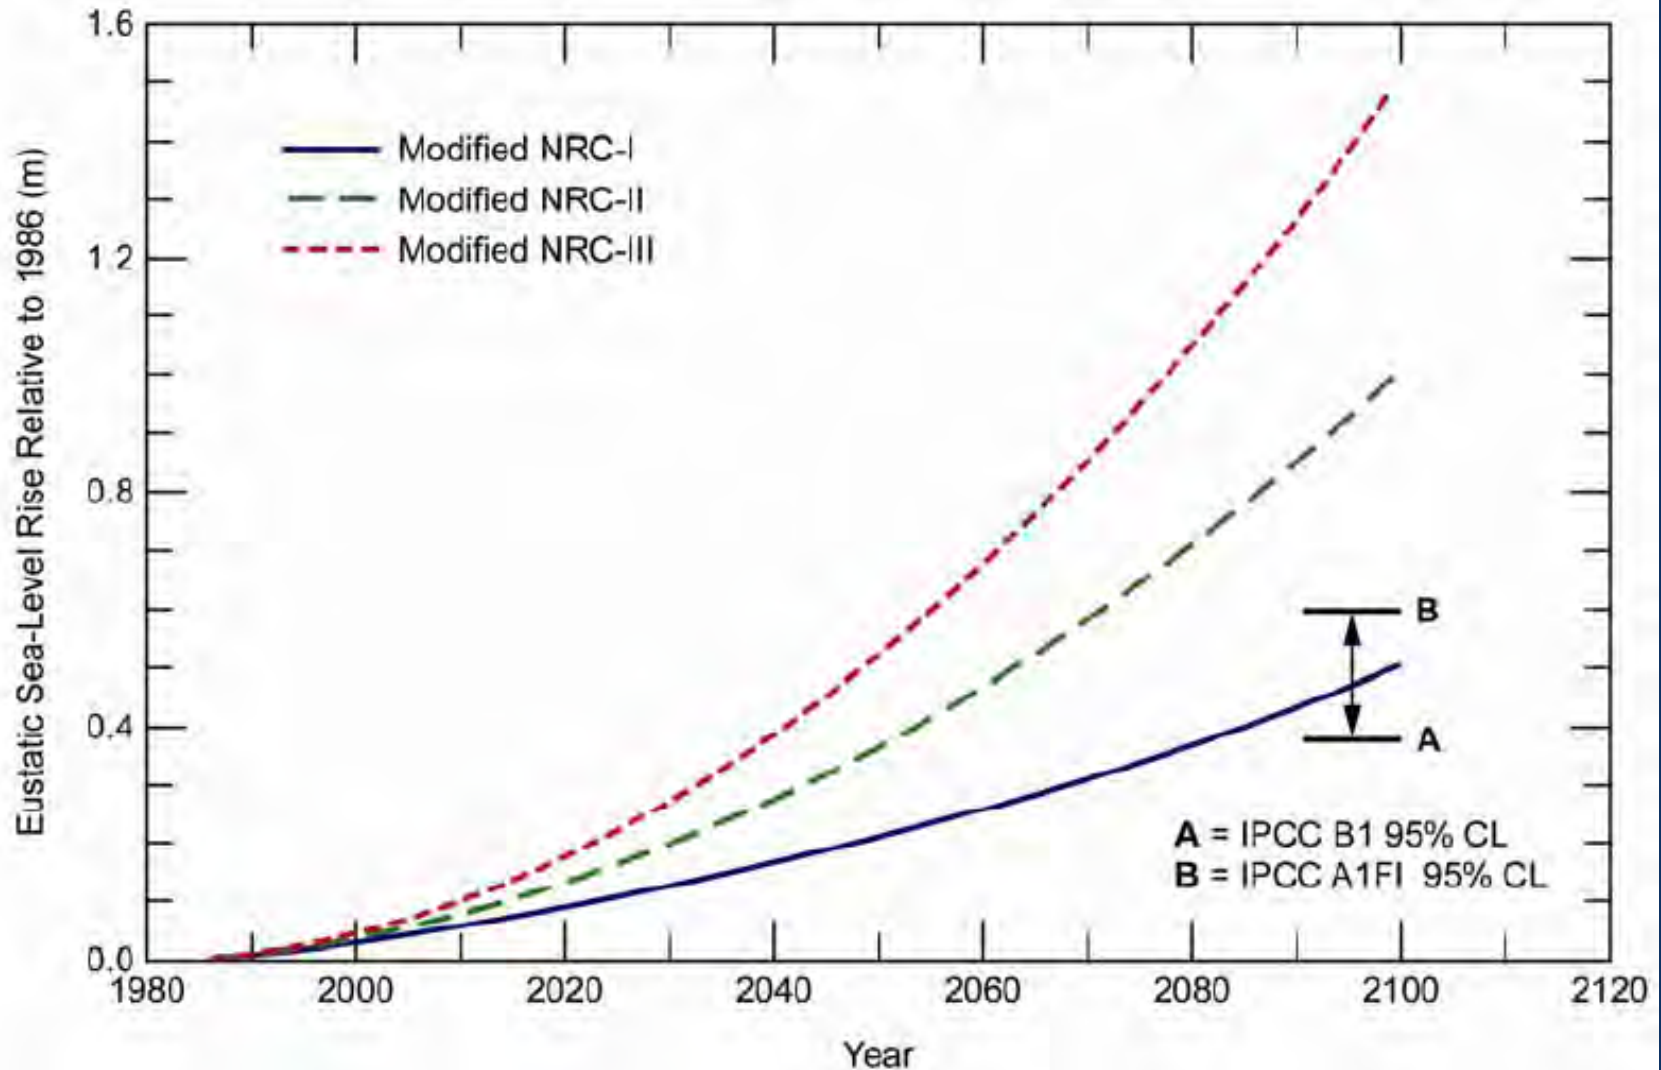
Figure B-11. Modified NRC (1987) eustatic sea-level rise scenarios and the IPCC (2007) scenario estimates for use in predicting future sea-level change.

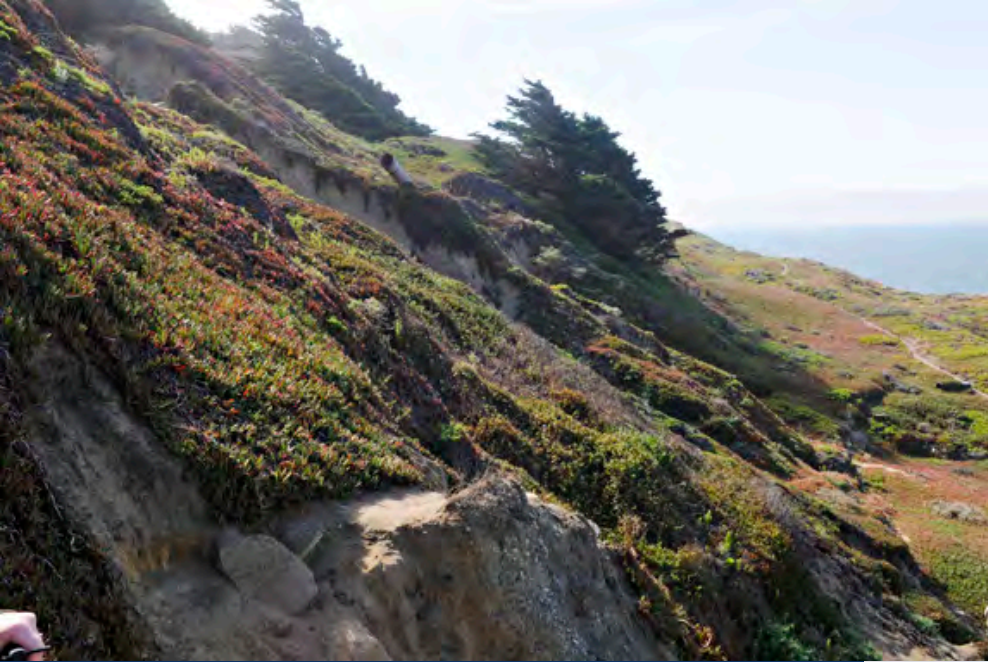
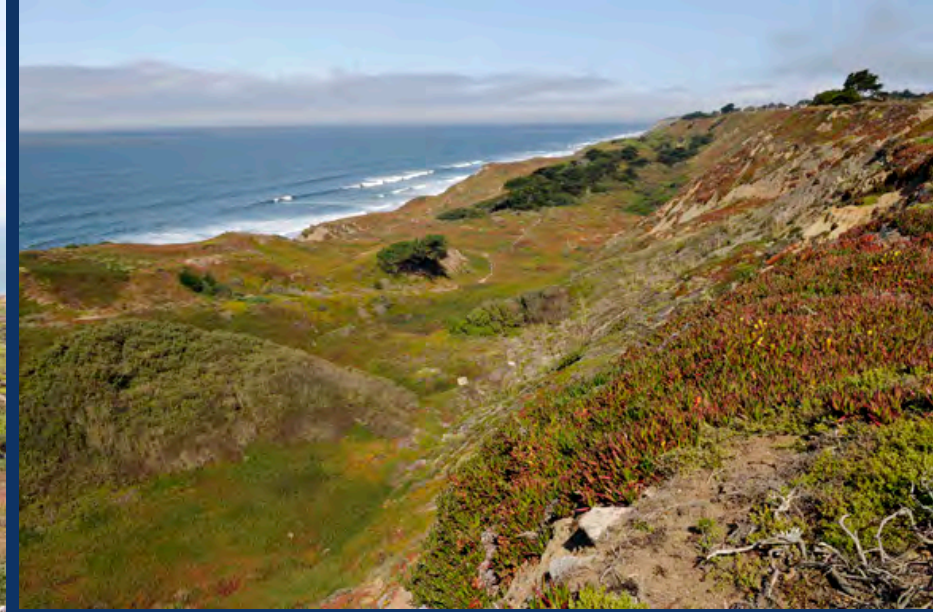
**09-8173-11\_Thornton\_Beach/  
Former paved highway, slumped  
and undercut by coastal erosion  
and failed cliffs, Thornton Beach,  
Daly City, CA  
Do Not Reproduce: © Bobbe'  
Christopherson, All Rights  
Reserved.**

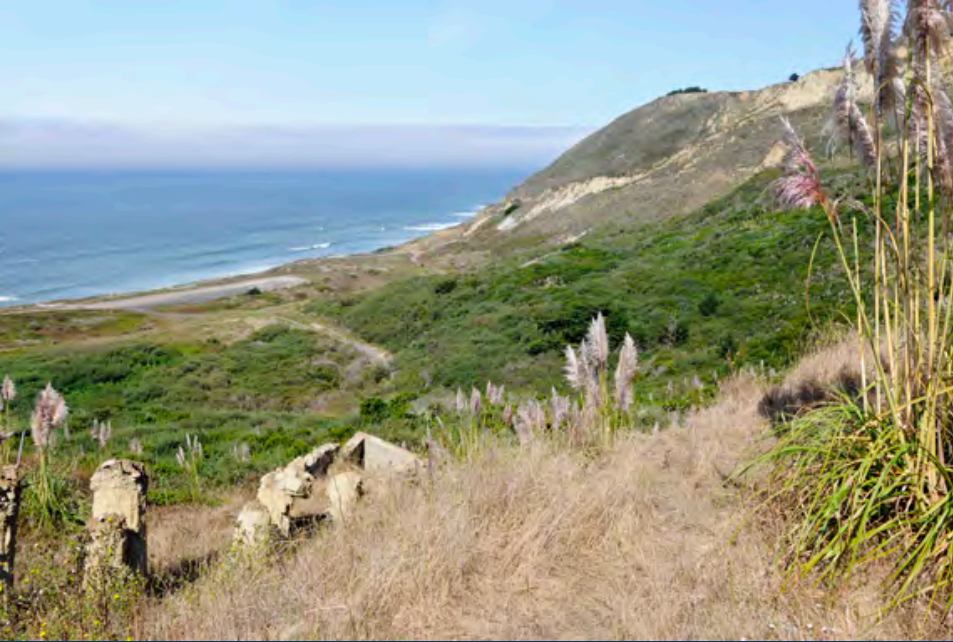
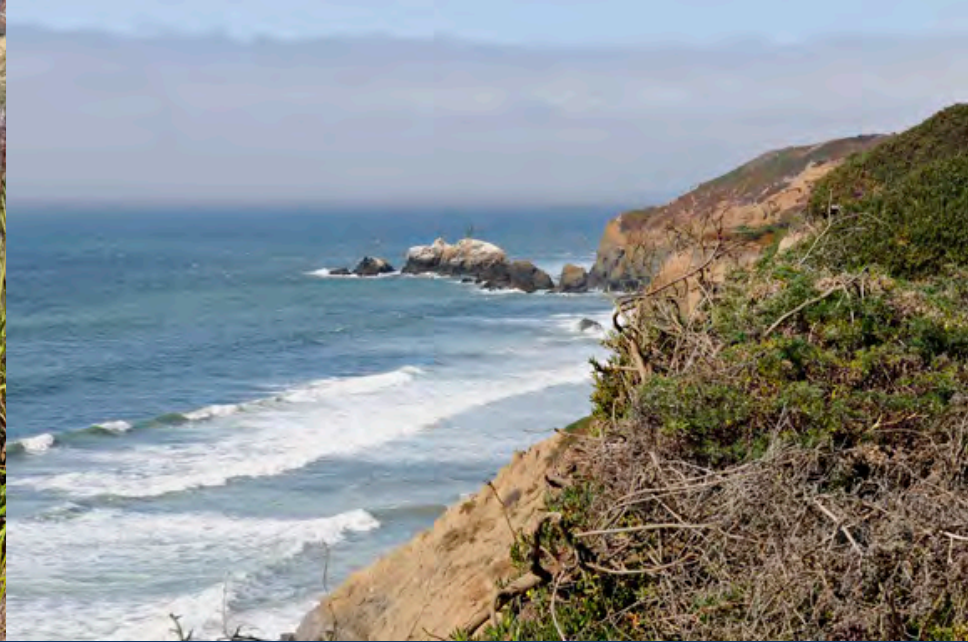
**09-8206-11\_Mussel\_Rock/ Mussel Rock  
slide area, concret foundation pillars  
are all that remain of a home destroyed  
by a massive slide, Daly City, CA**

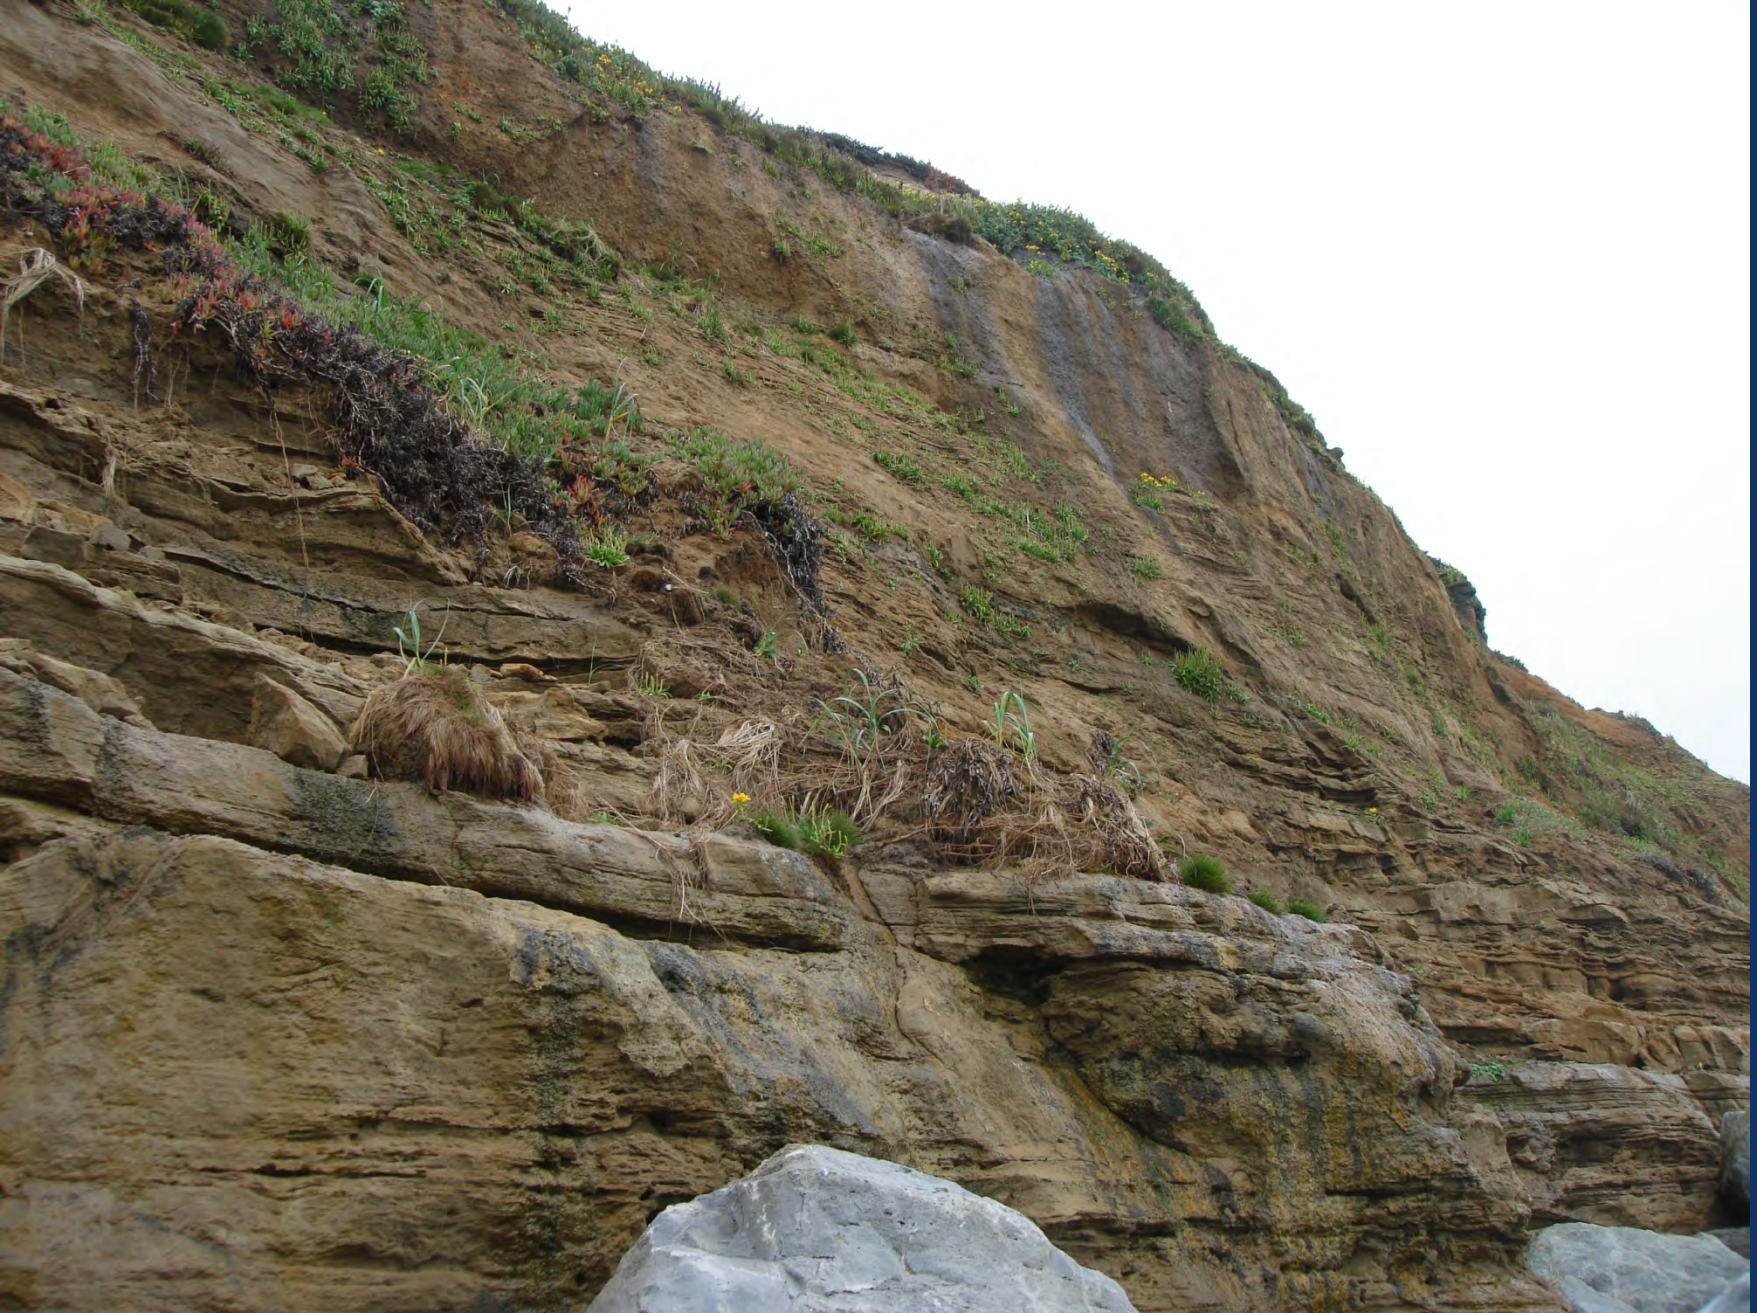
Layers and seeps; Manor Bluffs, Pacifica Aug 2010 © Bob Battalio, 2010

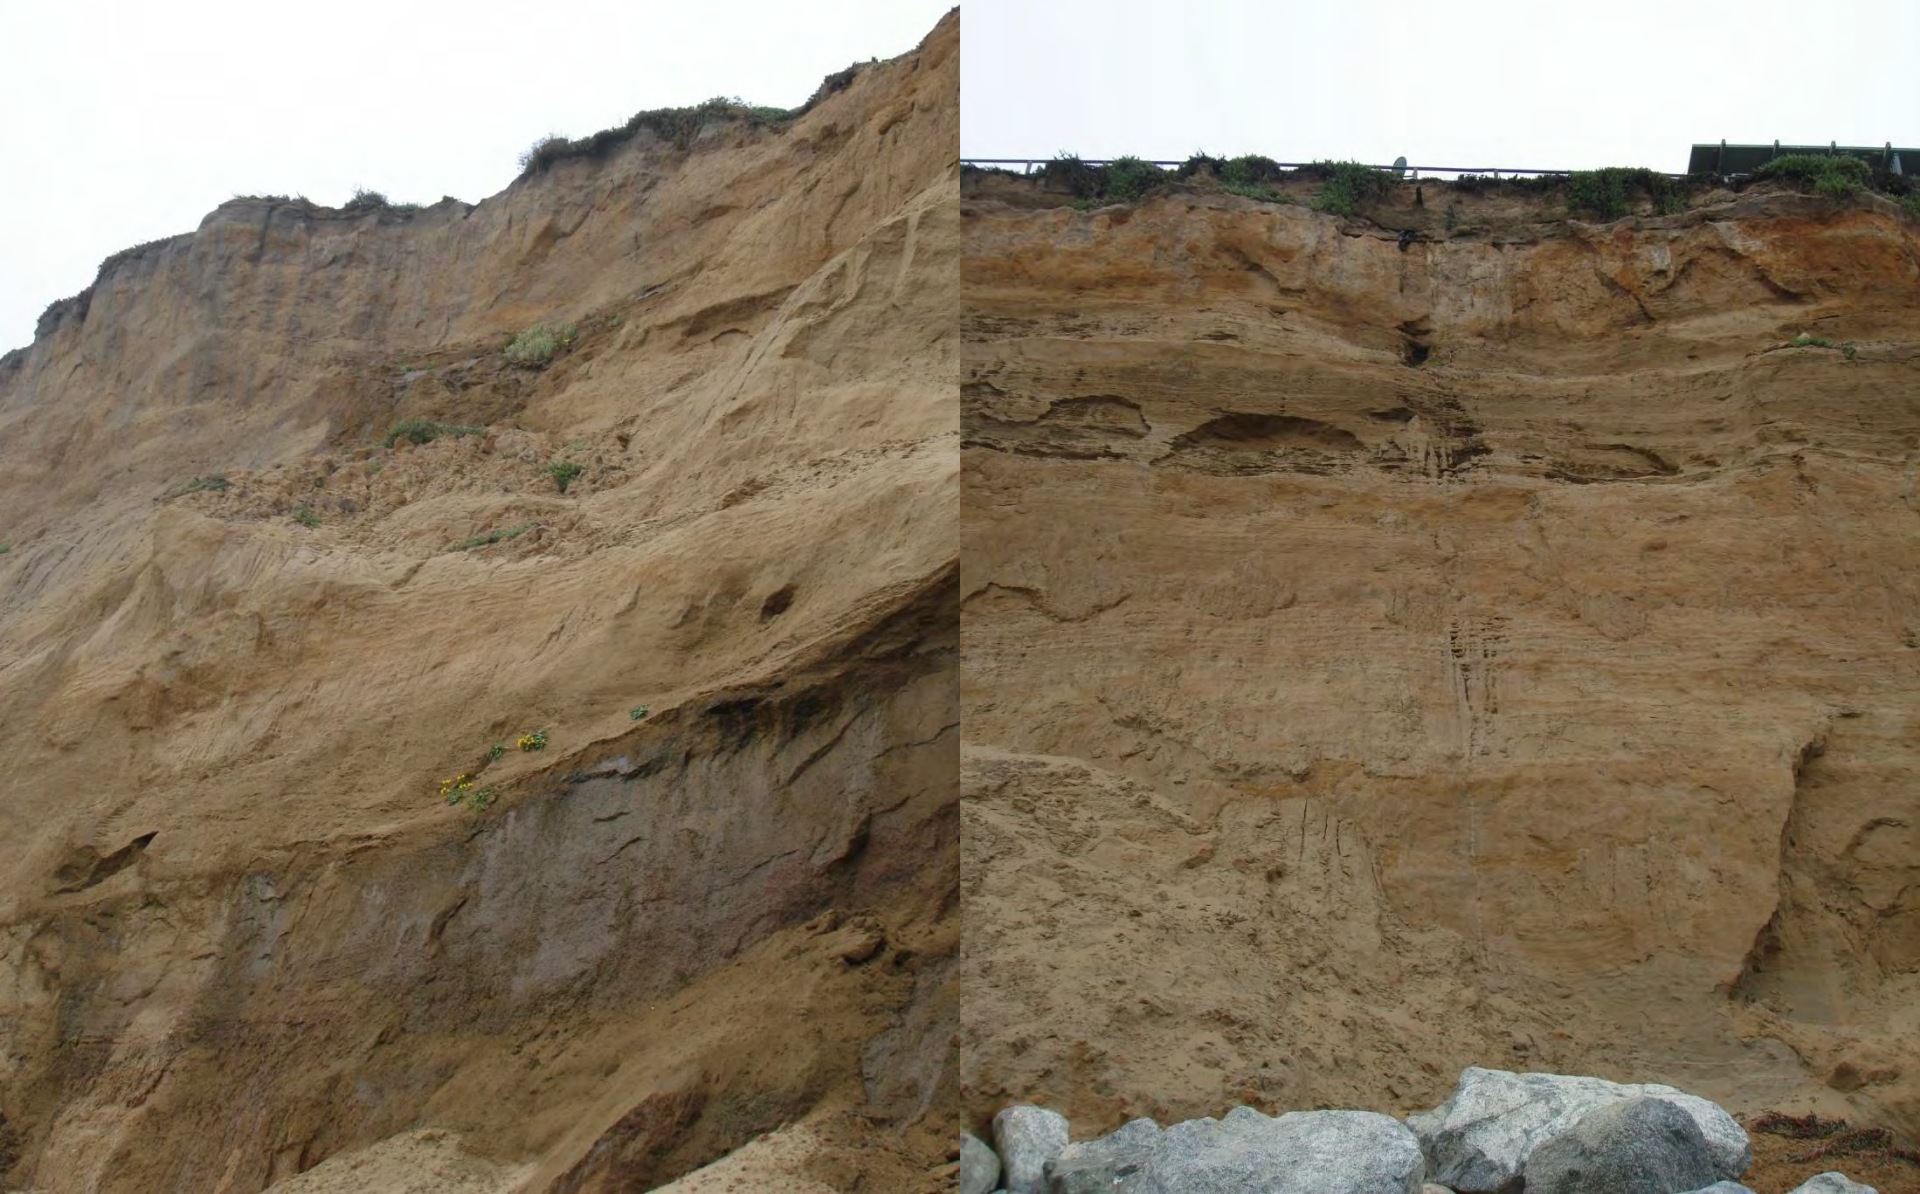
Seeps, rills and piping; Manor Bluffs, Pacifica Aug 2010 © Bob Battalio, 2010
