# Coastal Erosion Processes and Mitigation Measures

**San Francisco Littoral Cell, Pacifica Sub Cell**

**Bob Battalio, PE  
Principal Engineer, ESA PWA**

**November 14, 2012  
City of Pacifica**

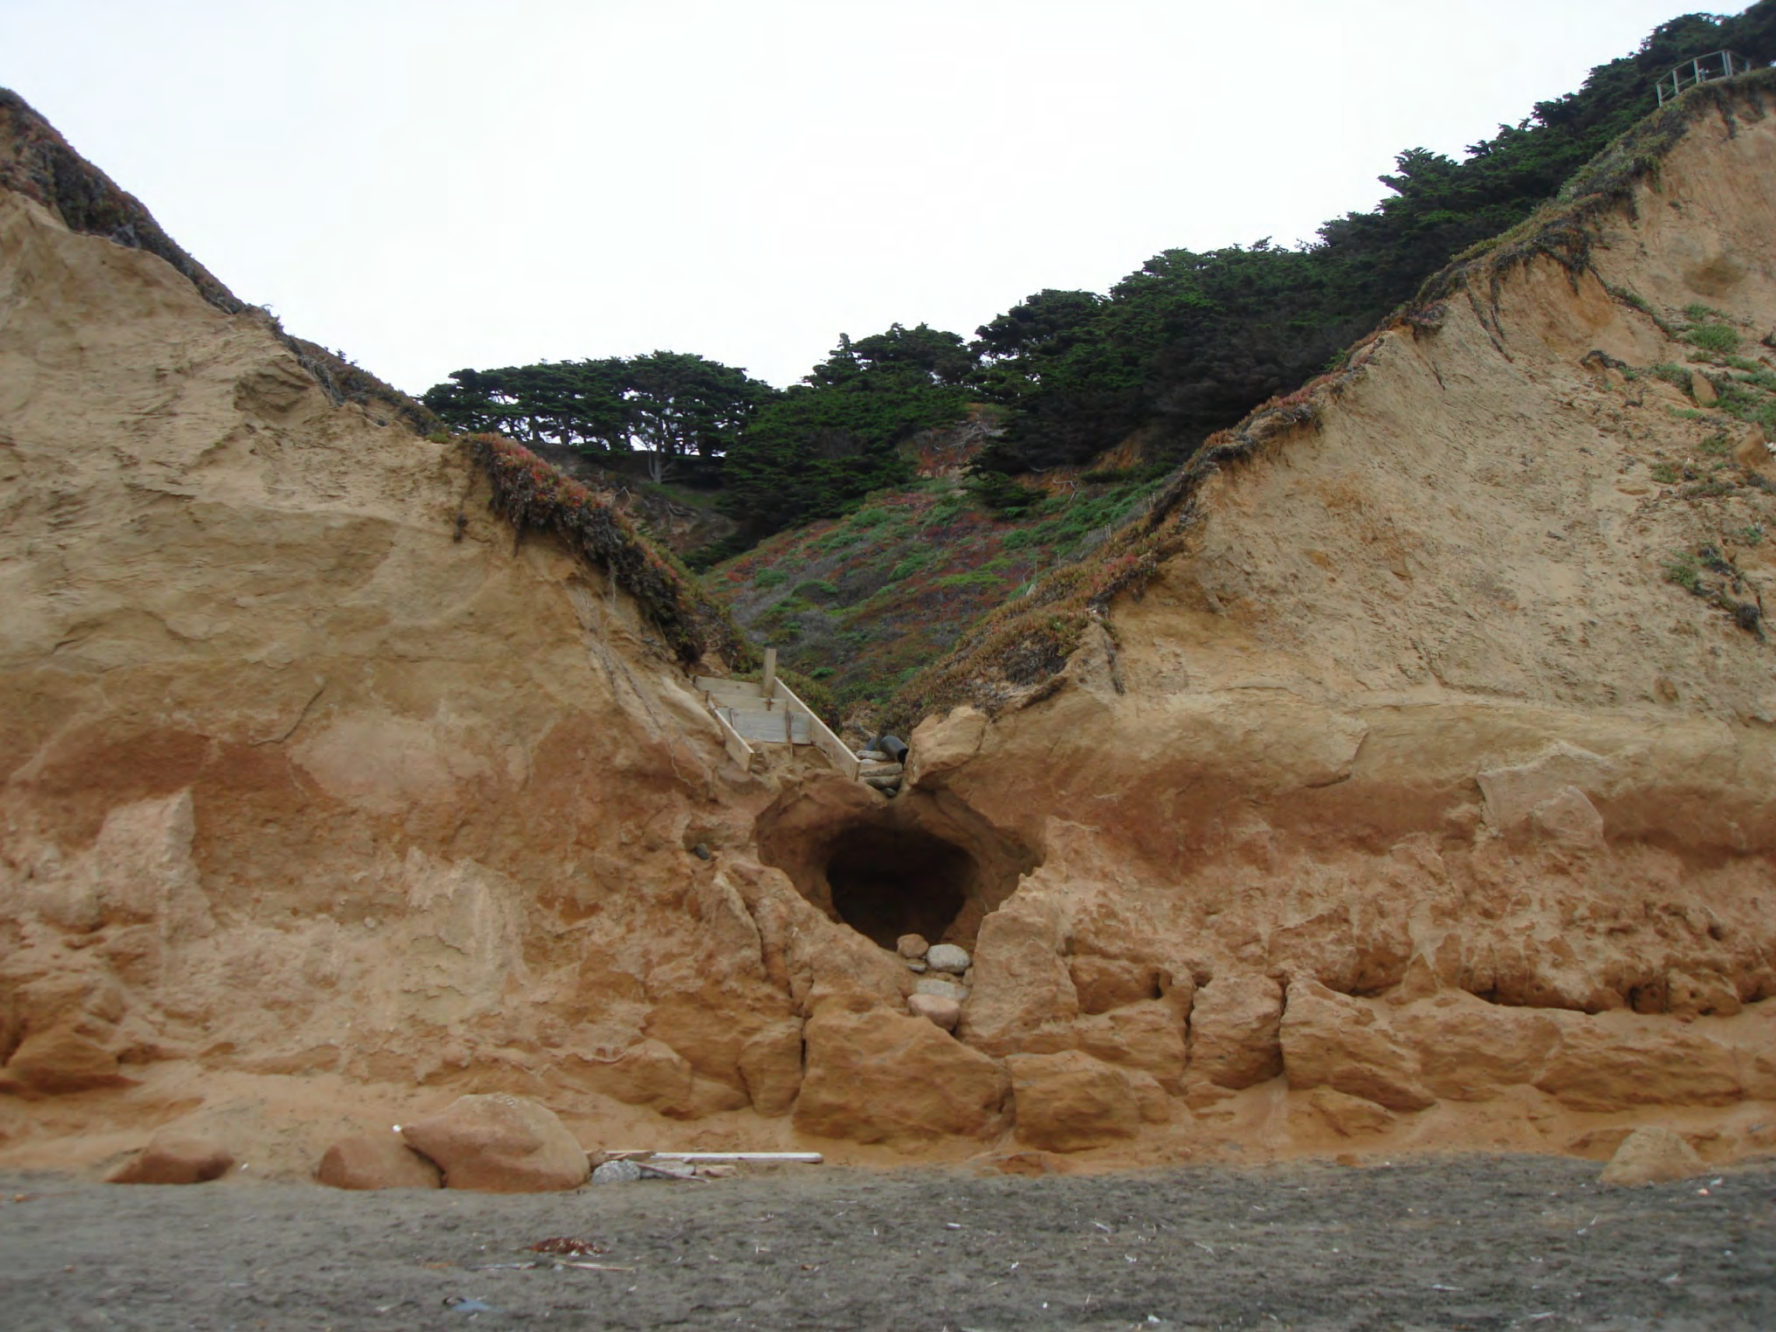
Piping ! Manor Bluffs, Pacifica Aug 2010 © Bob Battalio, 2010

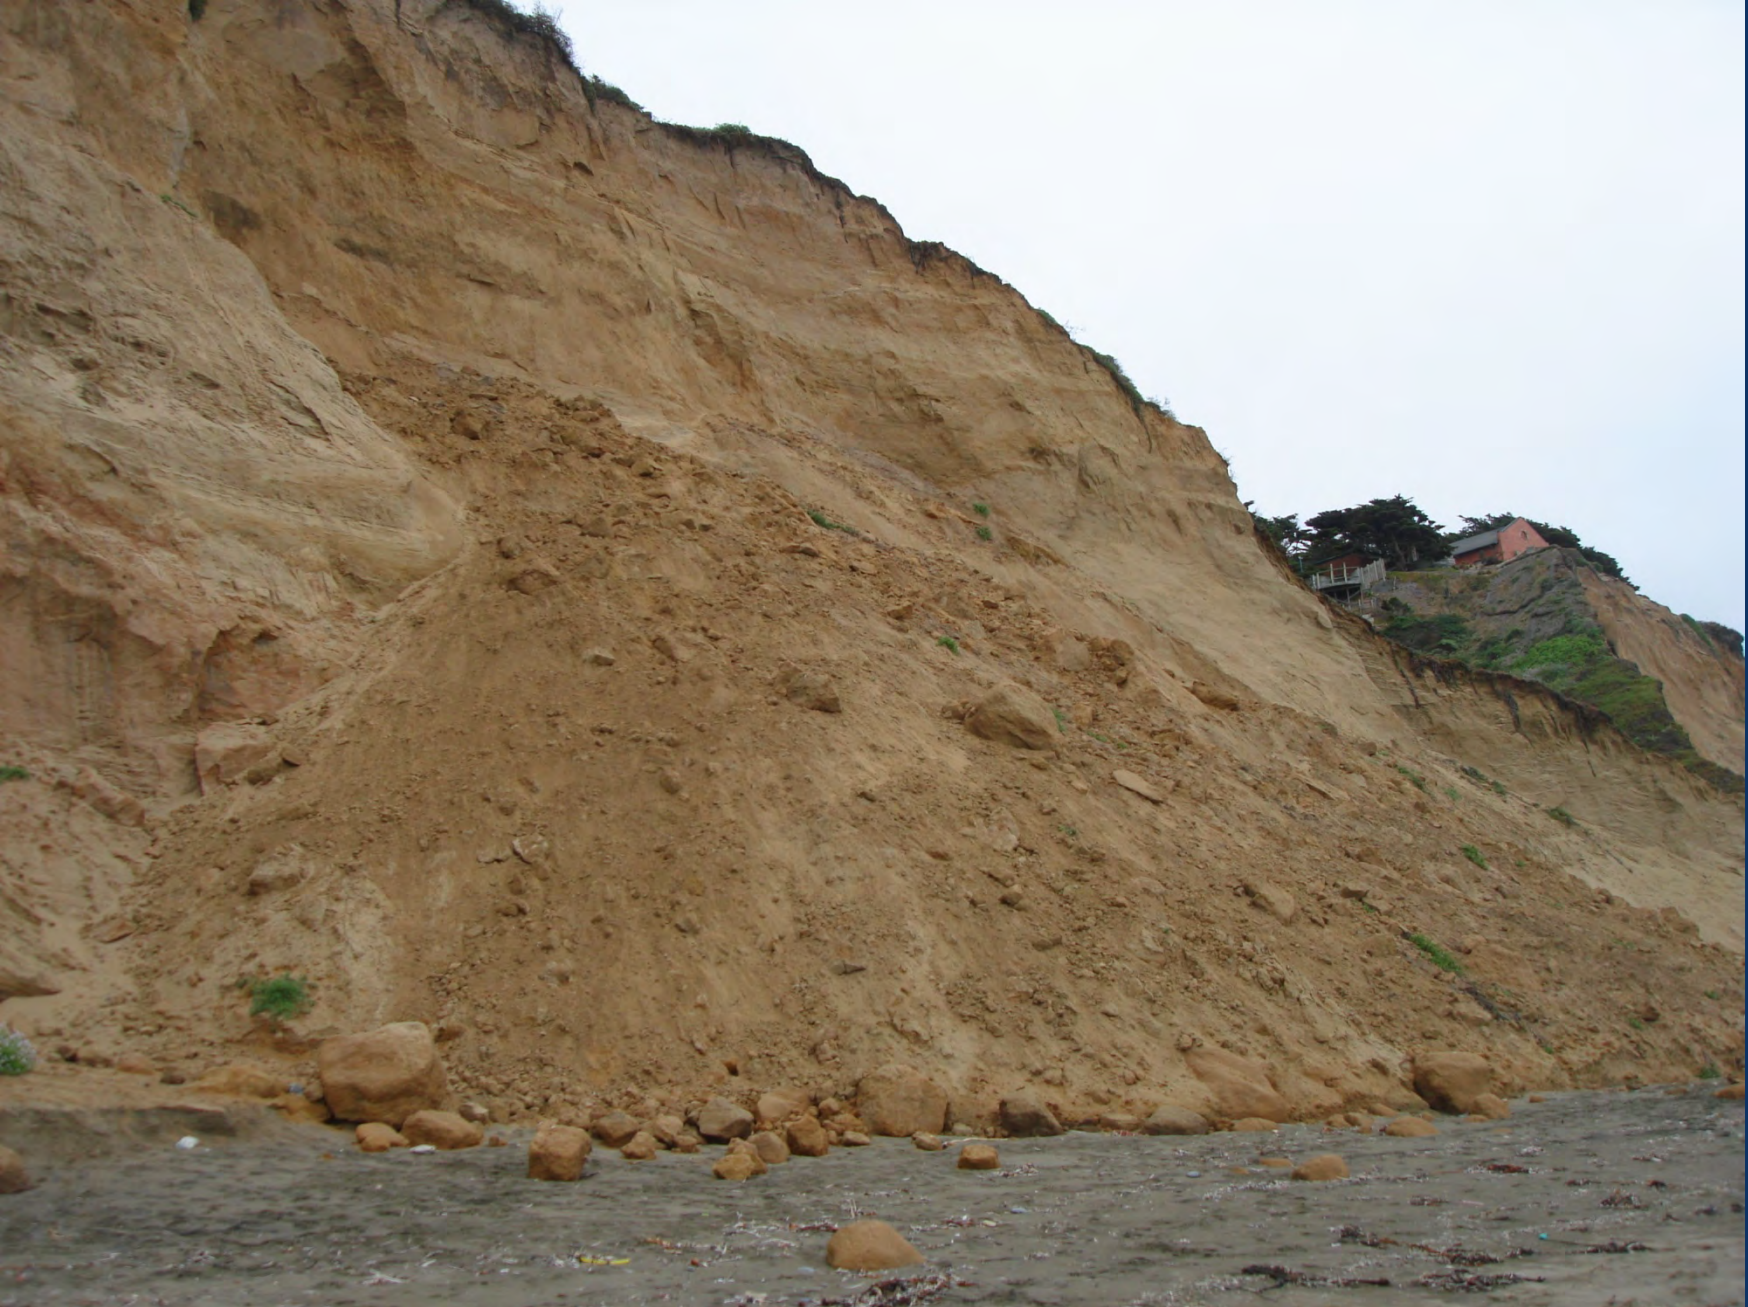
Talus cone; Manor Bluffs, Pacifica Aug 2010 © Bob Battalio, 2010

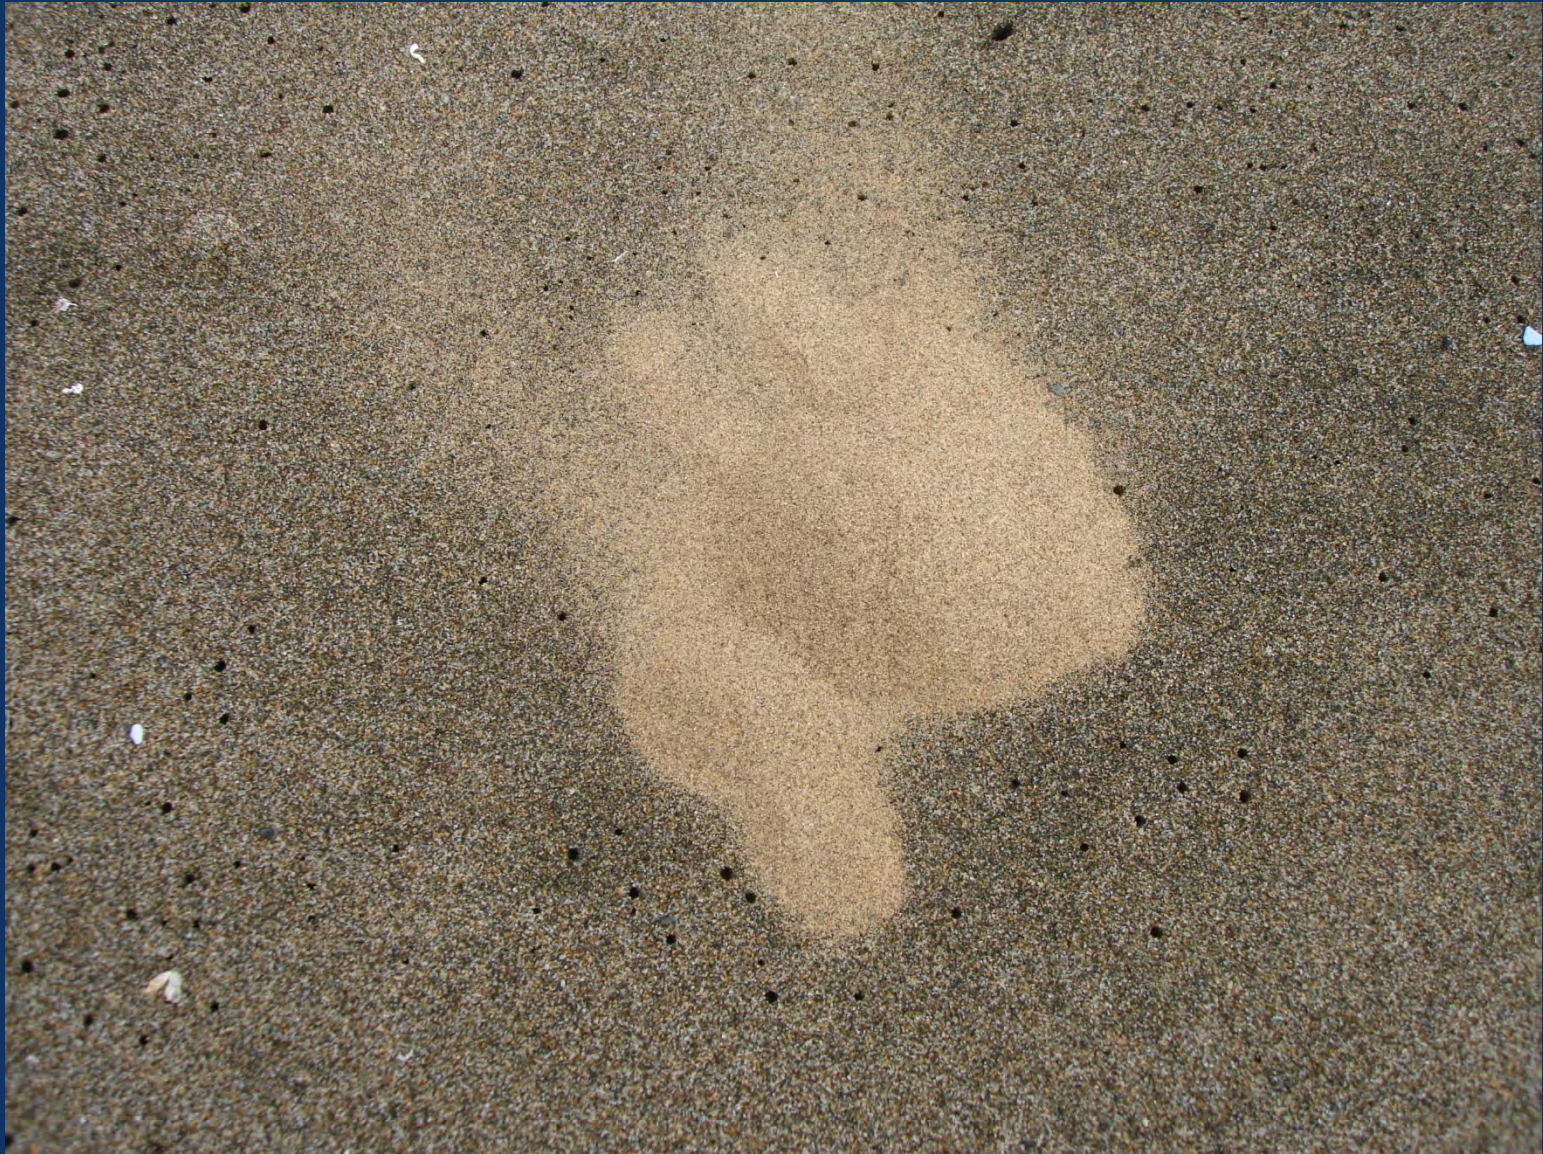
**Bluff sand compared to beach sand, Manor, Pacifica Aug 2010** © Bob Battalio, 2010

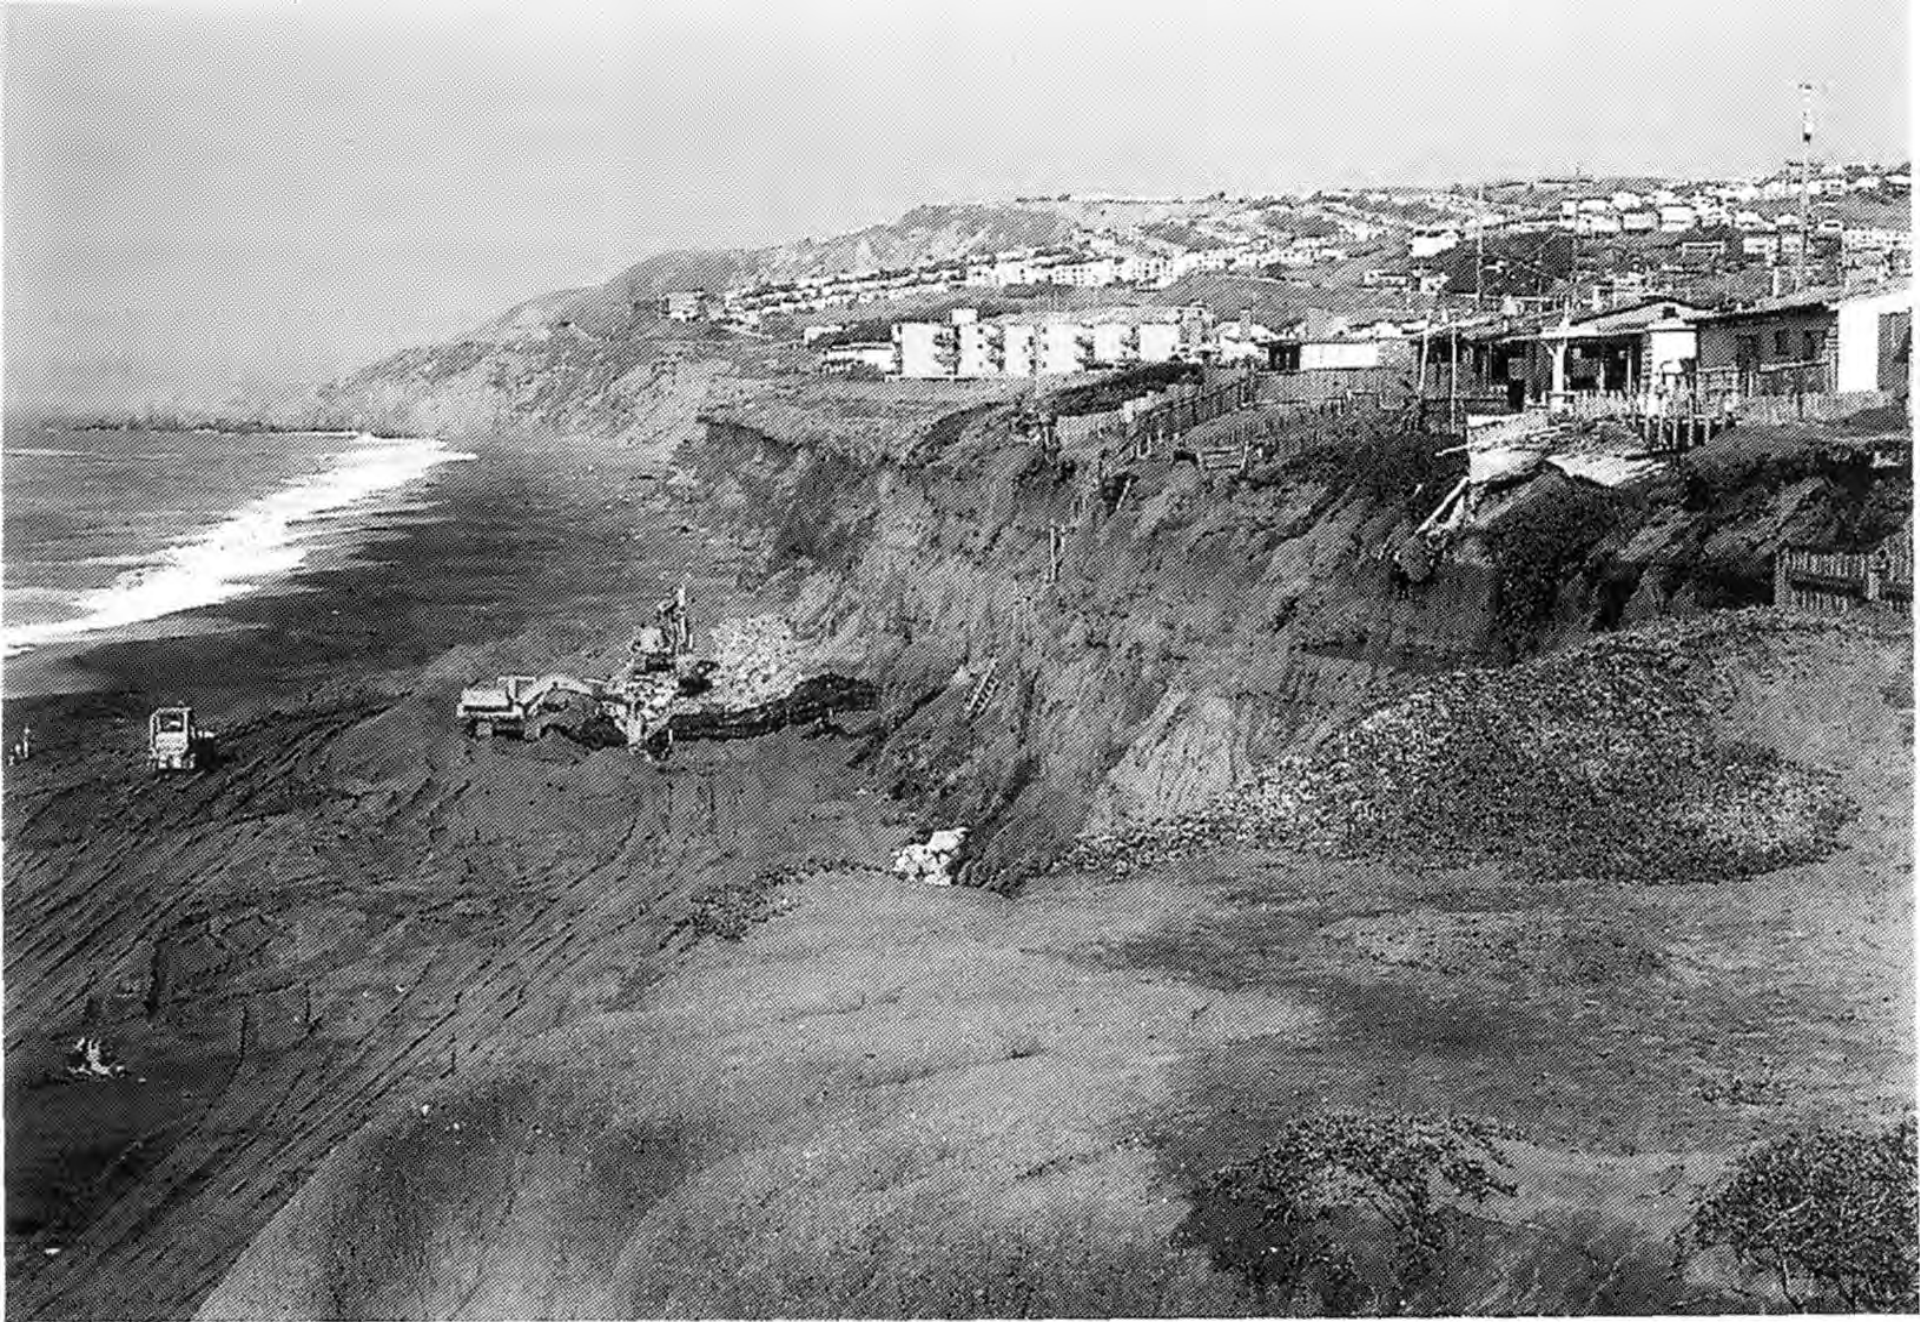
**Figure 2. Pacifica bluffs in October 1983, following the last major El Niño event on the California coast, when a rock revetment was constructed.**

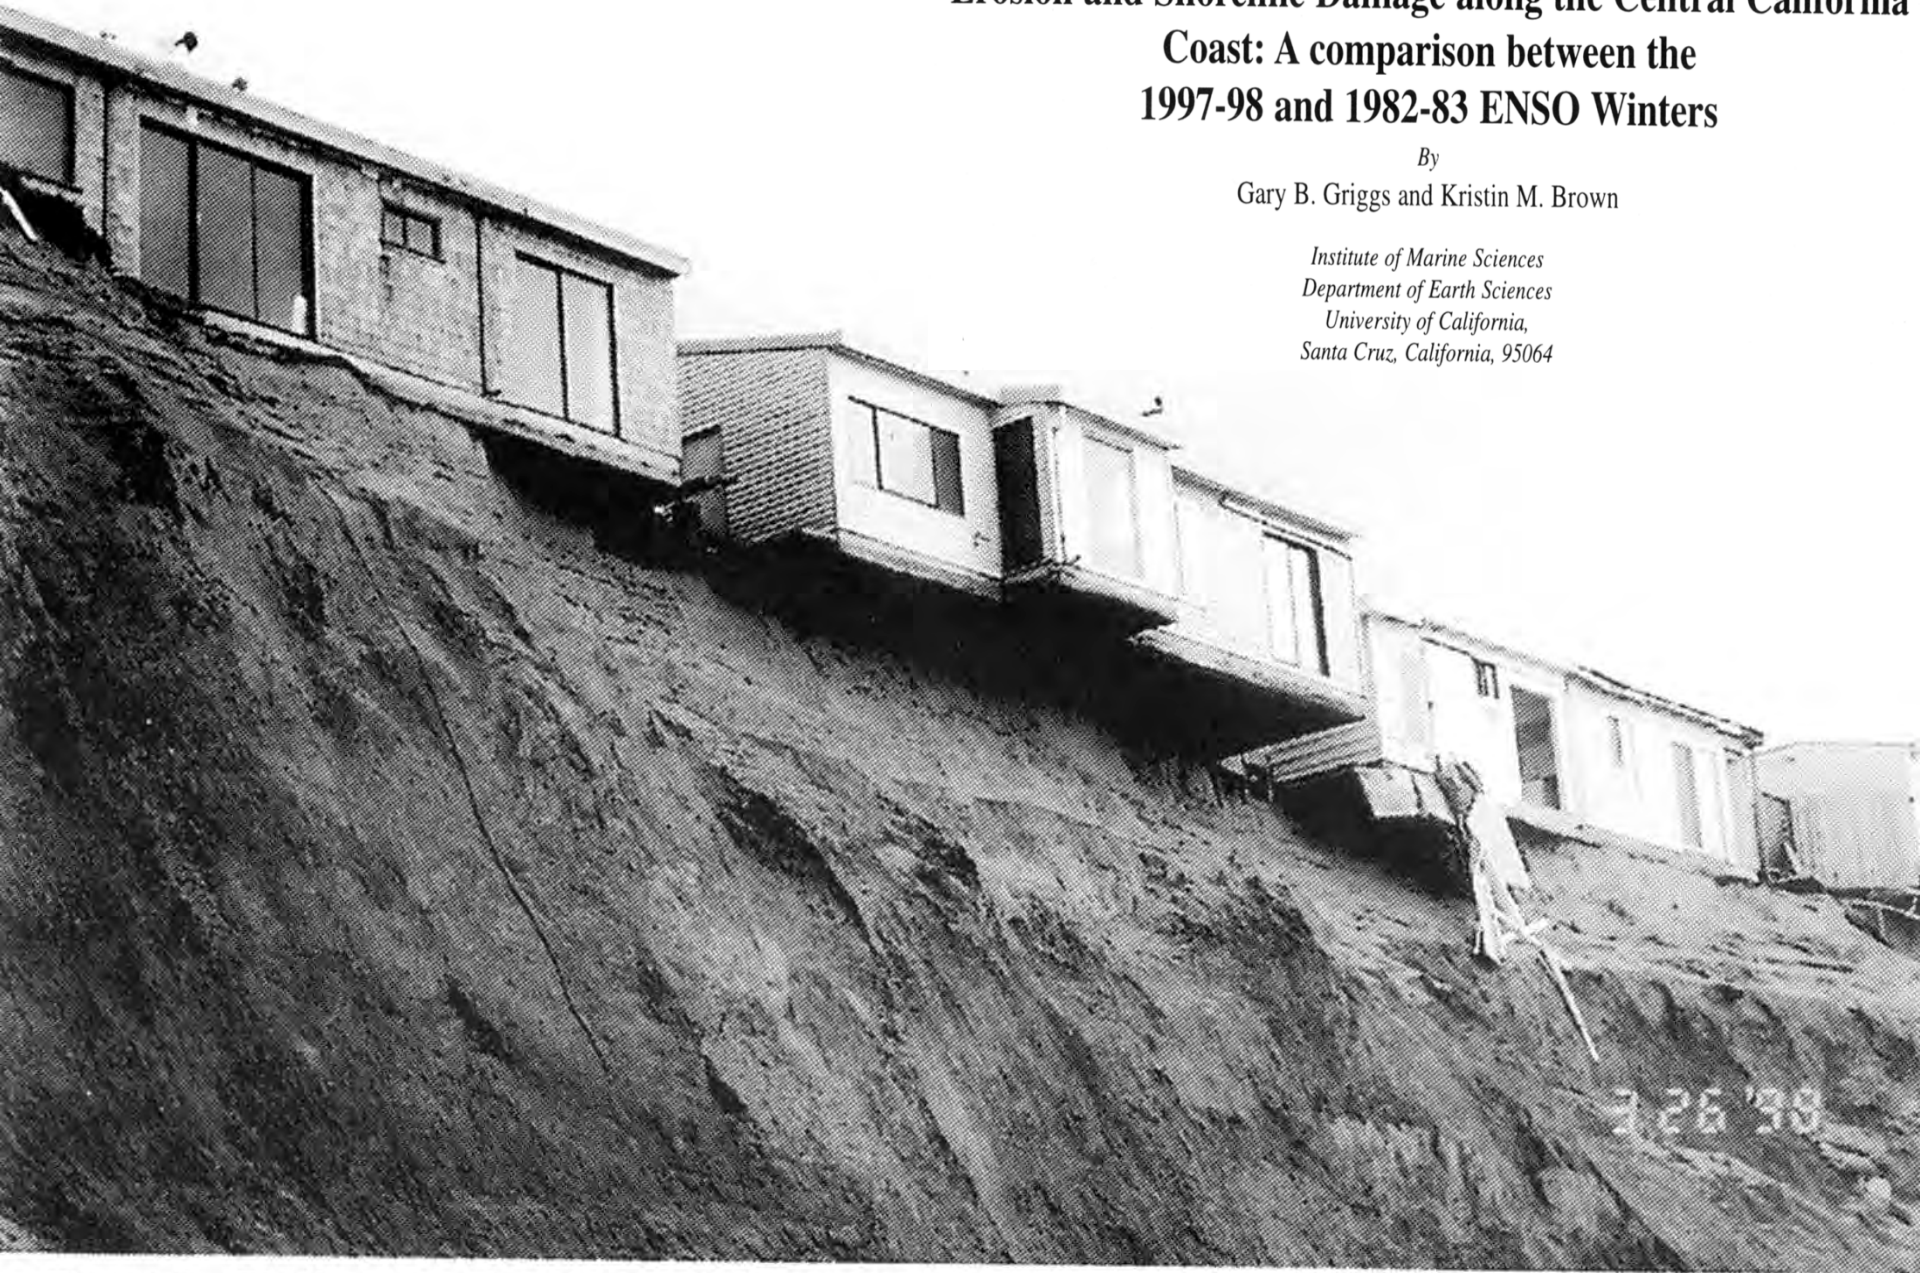
**Figure 1. Bluff erosion in Pacifica between January and March 1998 ultimately led to the demolition of ten homes in April (Photo by Monty Hampton, USGS).**

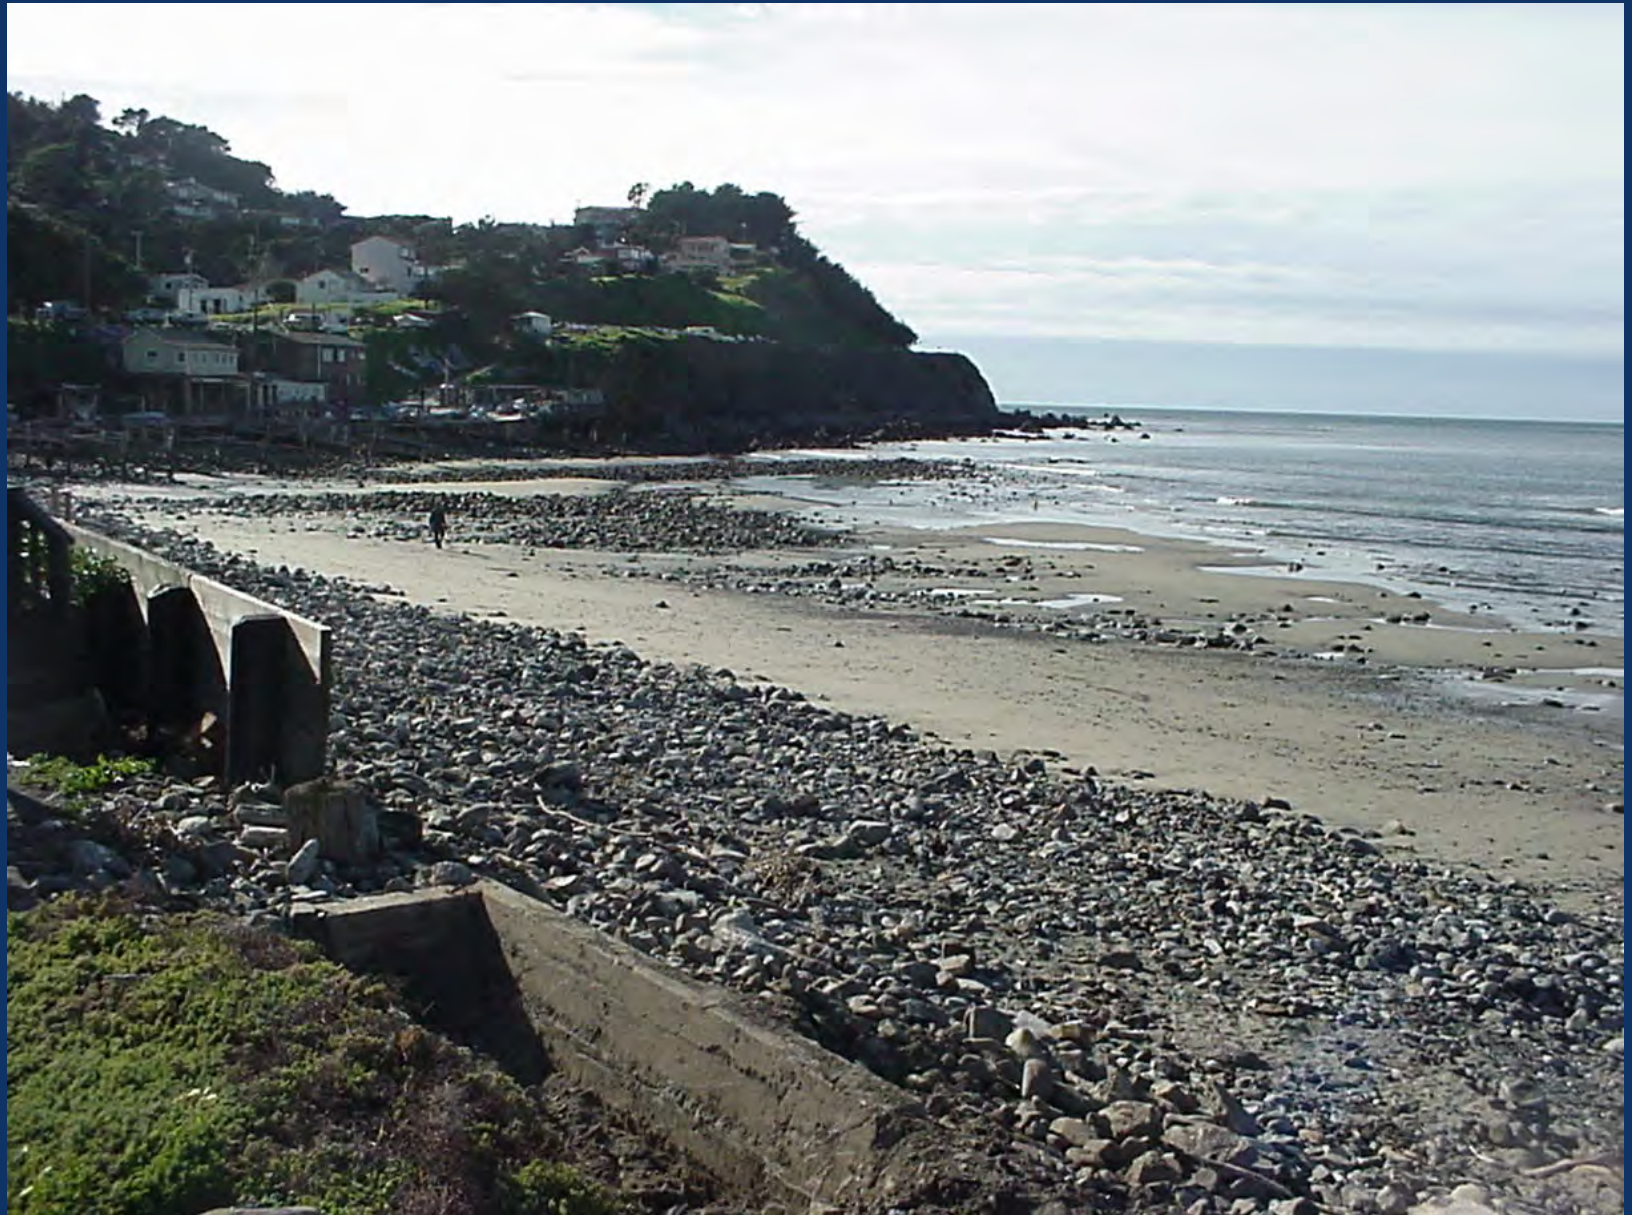
# Linda Mar – Pt San Pedro - cobble substrate with sand cover
